HAWTHORNE DRIVE COMPREHENSIVE STORMWATER MANAGEMENT STUDY

February 29, 2016

East Brandywine Township
1214 Horseshoe Pike
Downingtown, PA 19335

EXECUTIVE SUMMARY

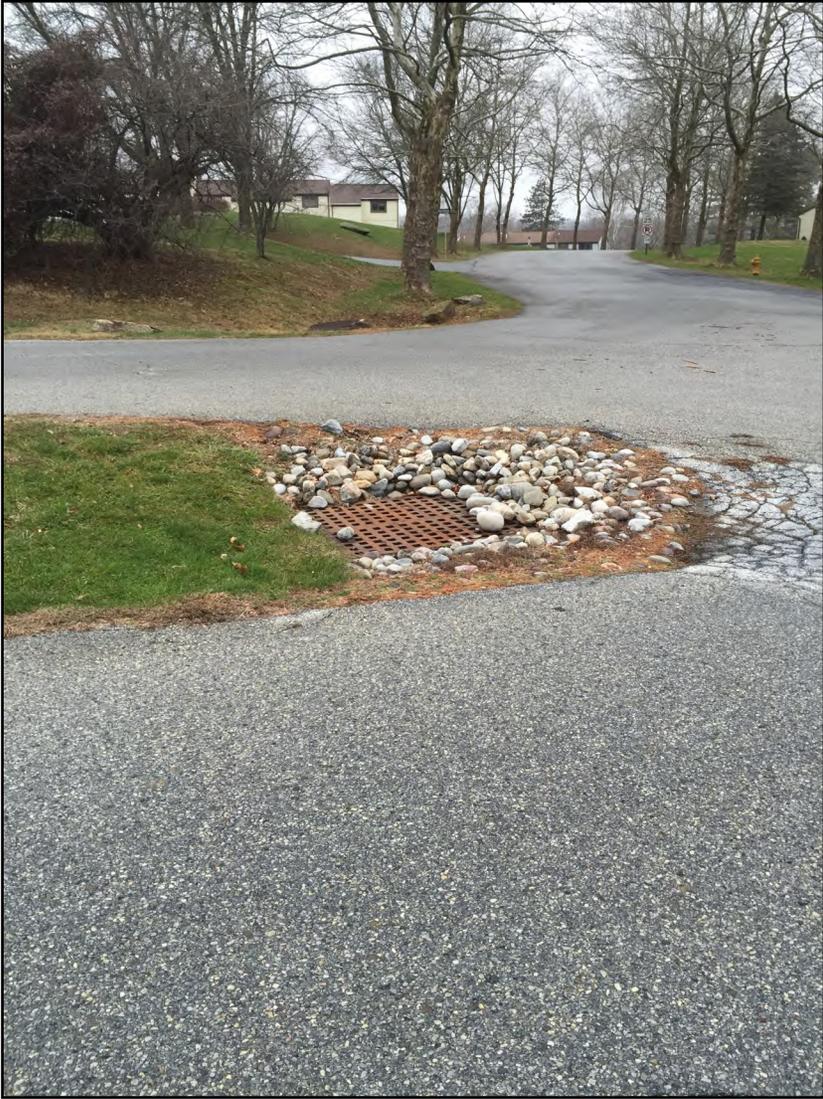
Structure ID & Size	Location	Structure Conditions	Associated Photos in Appendix E	Corrective Actions reported by Field Inspection
INLET #1 (4'X4' Brick)	Between north entrance of Hawthorne Dr & Clubhouse Rd	Sediment/debris approx. 1' deep	Photo 2	Clean out sediment/debris from bottom of inlet box
INLET #2 (2.5'X4' Brick)	SW corner of Highland Ct	Sediment/debris approx. 1' deep	Photo 4	Clean out sediment/debris from bottom of inlet box
INLET #3 (4'X4' Brick)	NE corner of Wyndham Ct	Sediment/debris approx. 1' deep	Photo 5	Clean out sediment/debris from bottom of inlet box
Outfall from INLET #3 (12" CMP)	143 Brookfield Ct	Sediment/debris at the bottom of pipe	Photo 6	Add topsoil over the top of 12" CMP outlet for about 5 feet from end of pipe and minor grading
INLET #4 (2.5'X4' Brick)	SW corner of Windemere Ct	Sediment/debris approx. 1' deep	Photo 7	Clean out sediment/debris from bottom of inlet box

Photograph 2: Inlet #1

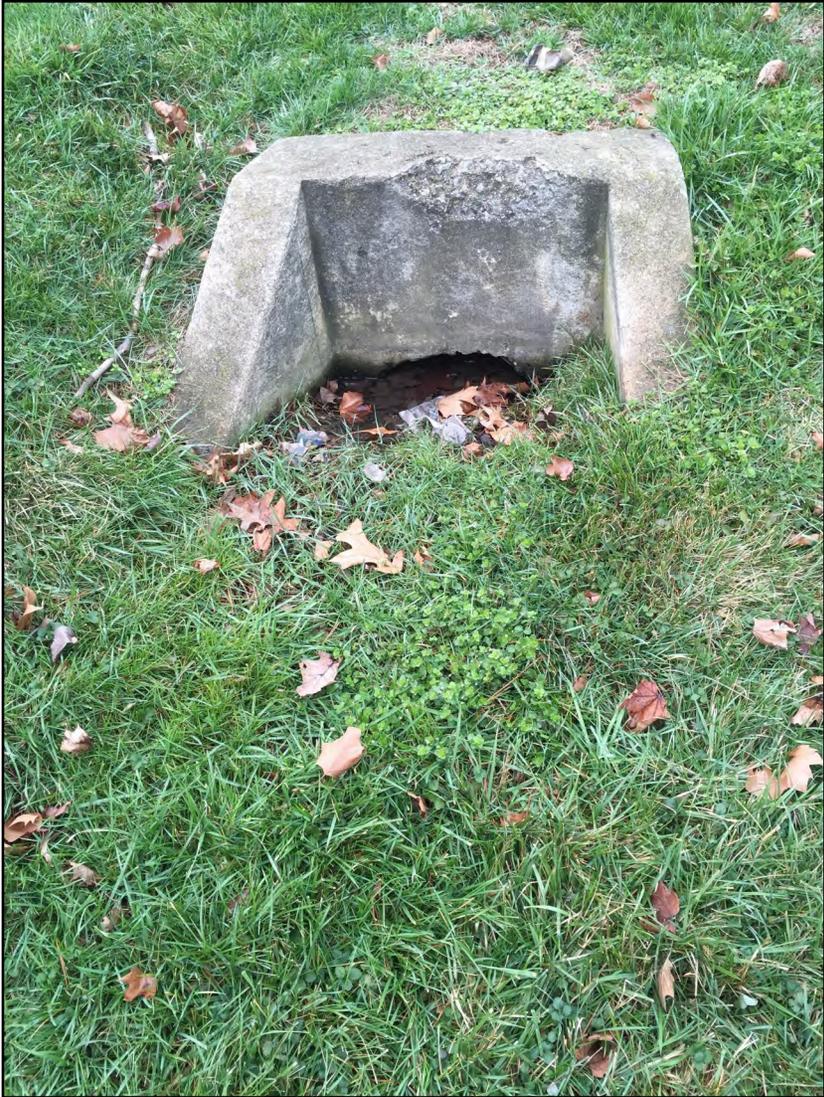
ENDWALL #1 (Concrete)	Between north entrance of Hawthorne Dr & Clubhouse Rd	75% of 15" CMP is covered with sediment/debris	Photo 3	Clean out sediment/ debris from bottom of pipe and minor regrading
HEADWALL #2 (Concrete)	Between Cambridge Ct & Suffolk Ct	Satisfactory	Photo 12	None
CULVERT (42" CMP)	Between Canterbury Ct & Gloucester Ct	42" CMP bottom rusting/corroded, pipe has lost its structural integrity; chance of collapse	Photo 14	Replace entire length of 42" CMP
ENDWALL #2 (Concrete)	Between Canterbury Ct & Gloucester Ct	Sediment, debris & rocks at the end of 42" CMP, riprap apron full of sediment	Photo 13	Install new riprap & clean out the vicinity of Endwall #2

Photograph 3: Endwall #1

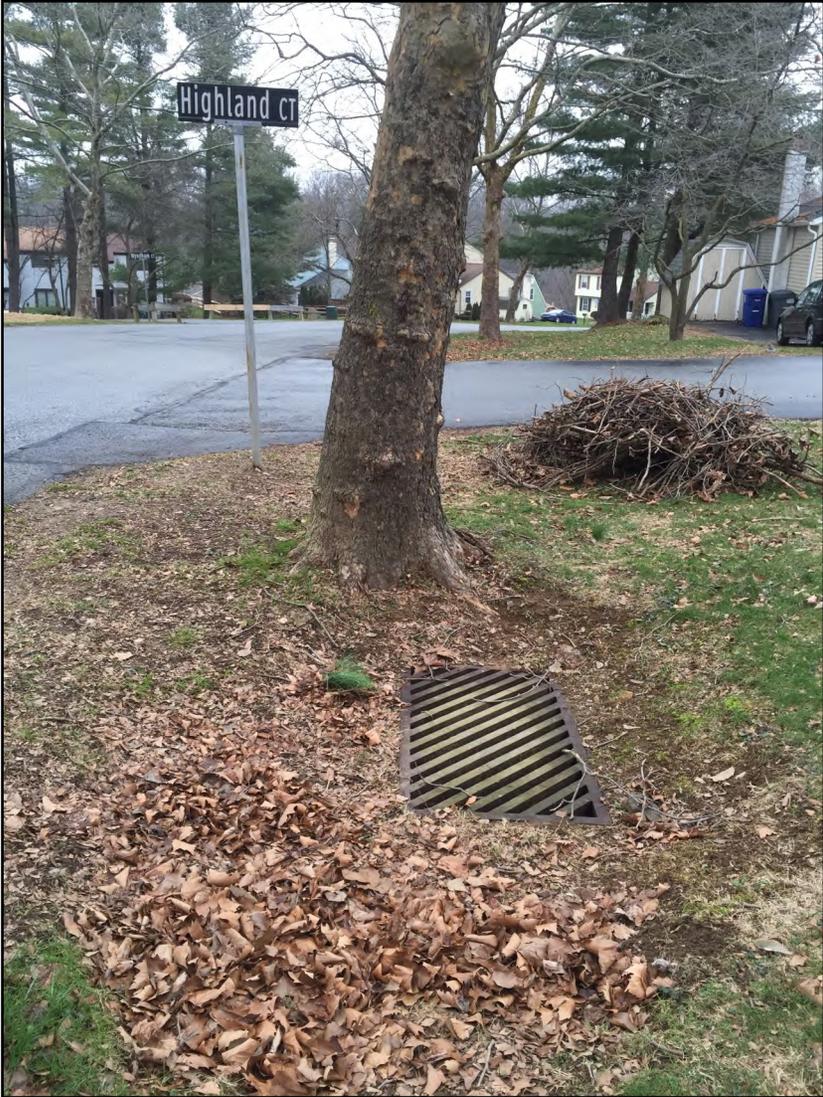
Photograph 4: Inlet #2

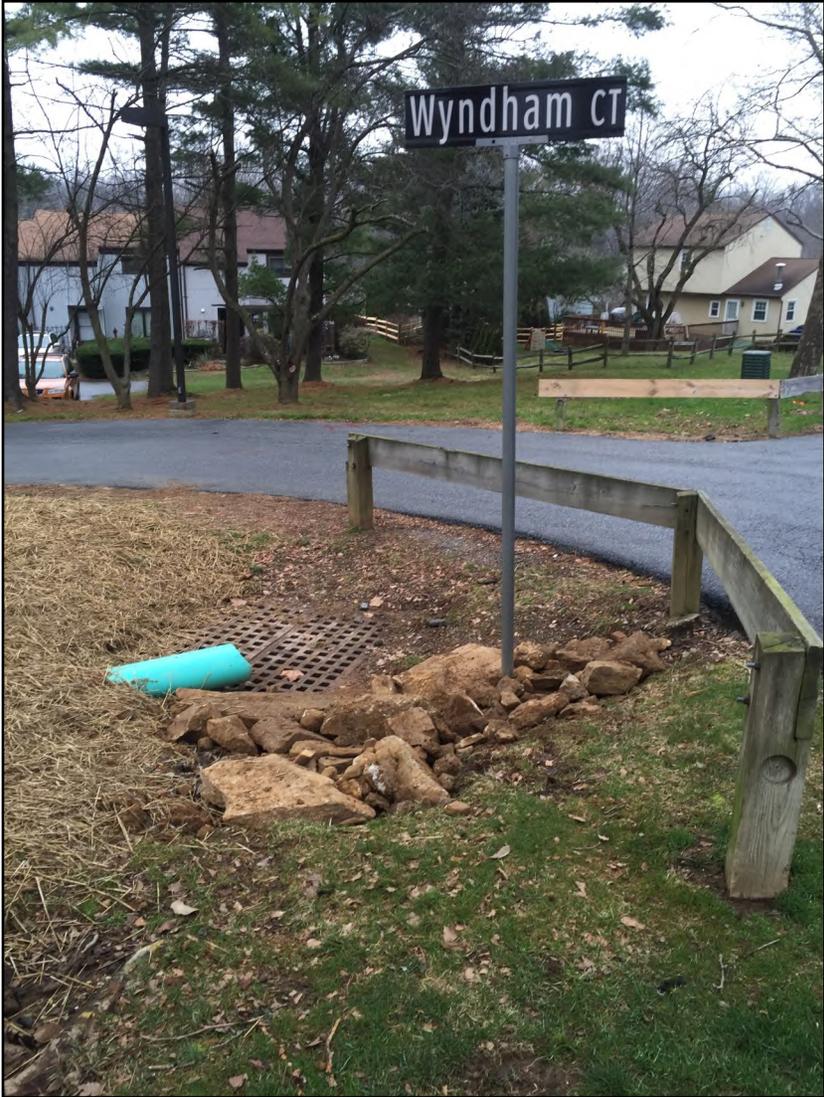
Photograph 5: Inlet #3

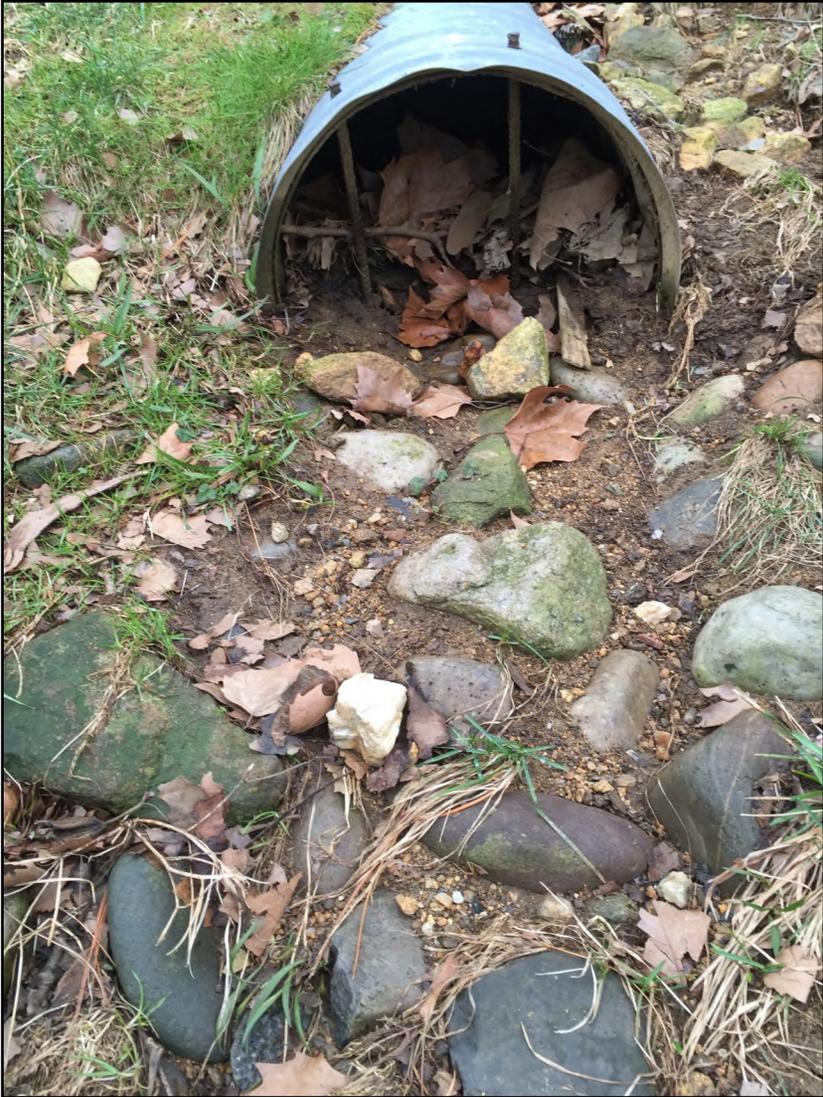
Photograph 6: Inlet #3 Outfall

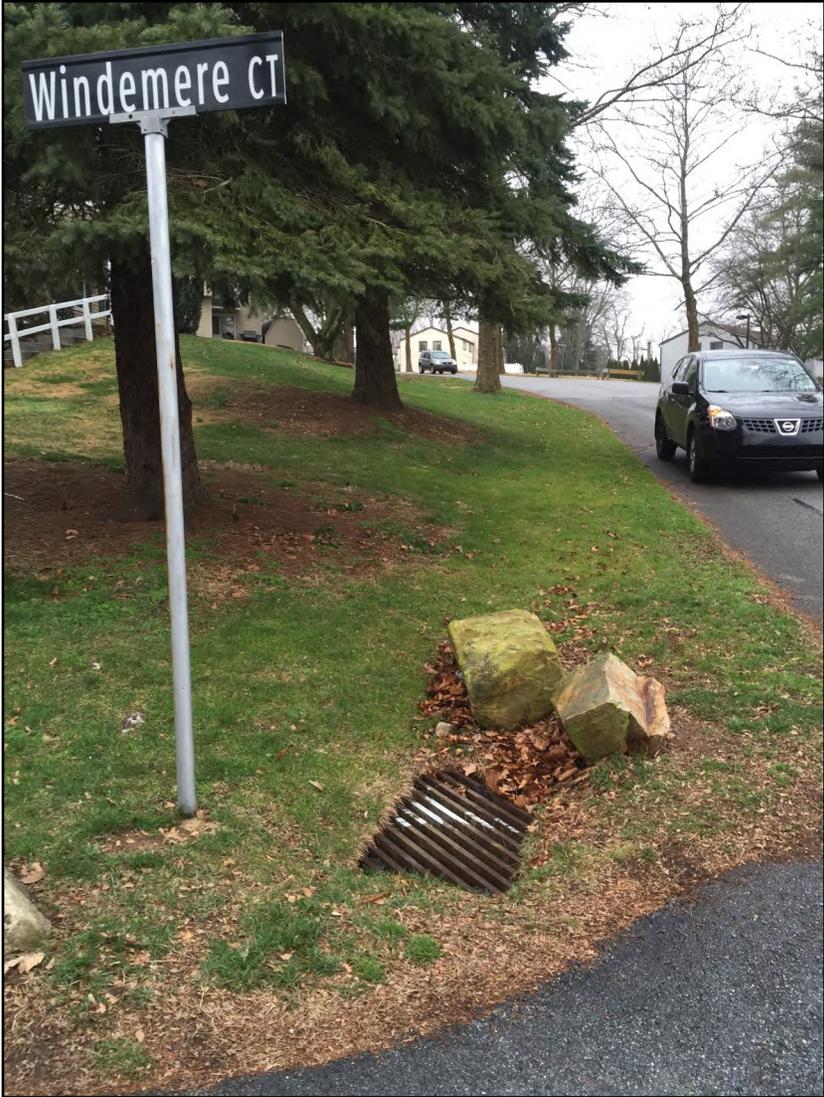
Photograph 7: Inlet #4

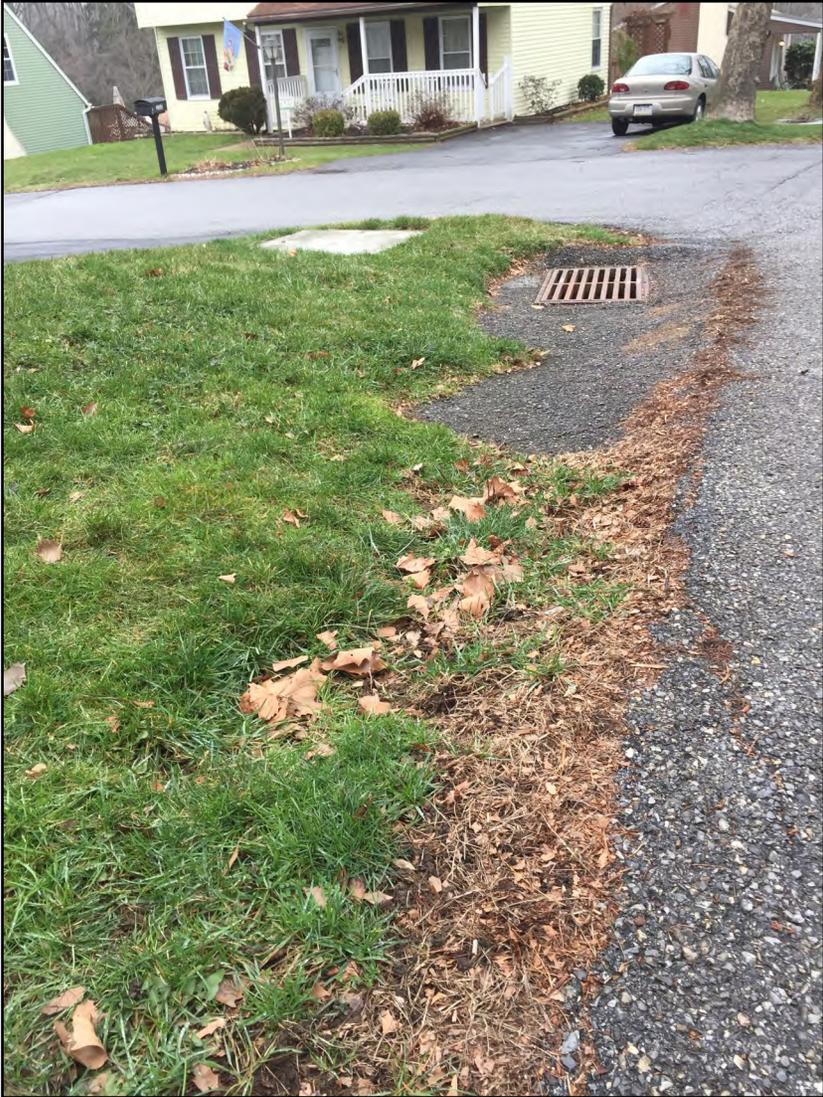
Photograph 8: Inlet #5

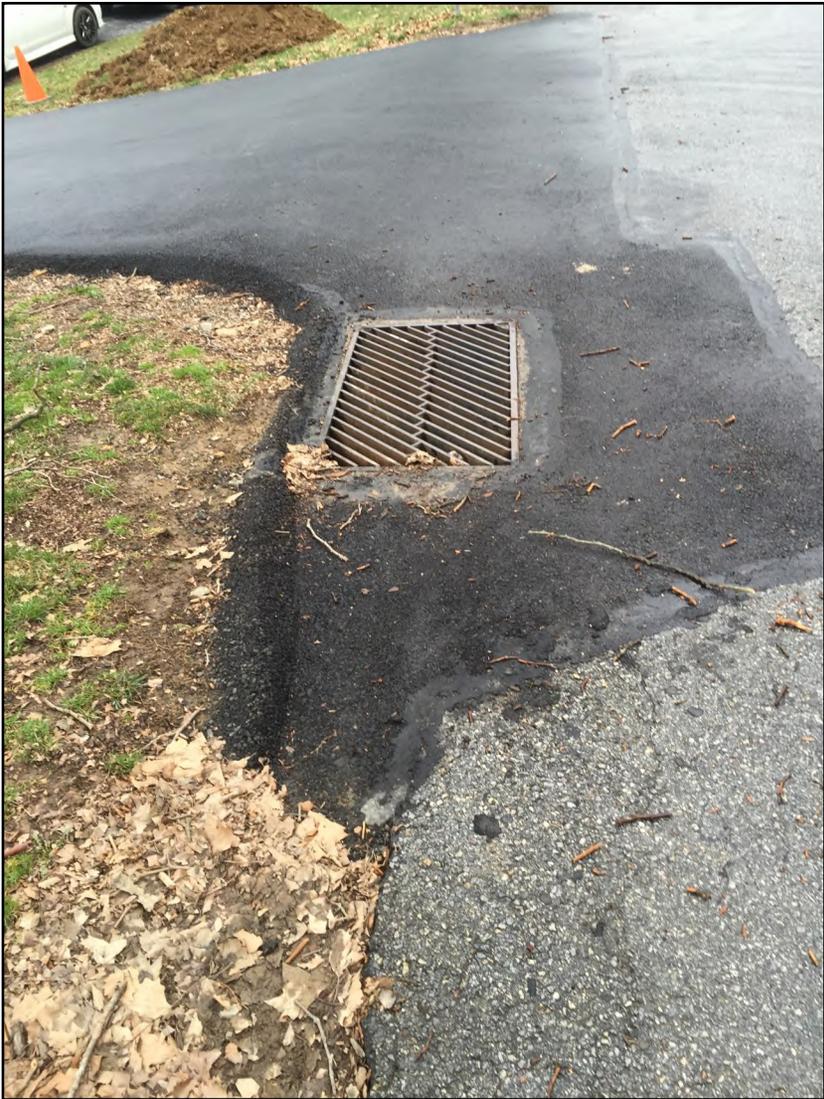
Structure ID & Size	Location	Structure Conditions	Associated Photos in Appendix E	Corrective Actions reported by Field Inspection
INLET #6 (2'X4' Concrete)	NE corner of Lambeth Ct	Sediment/debris approx. 1' deep	Photo 9	Clean out sediment/debris from bottom of inlet box
INLET #7 (2'X4' Brick)	SE corner of 122 Lambeth Ct	Sediment/debris approx. 1' deep	Photo 10	Clean out sediment/debris from bottom of inlet box
INLET #8 (2'X4' Brick)	NE corner of 23 Windemere Ct	Sediment/debris approx. 1' deep	Photo 11	Clean out sediment/debris from bottom of inlet box
INLET #9 (2'X4' Concrete)	NW corner of Canterbury Ct	Sediment/debris approx. 1' deep	Photo 15	Clean out sediment/debris from bottom of inlet box
INLET #10 (2'X4' Concrete)	NW corner of Chatham Ct	Sediment/debris approx. 1' deep	Photo 16	Clean out sediment/debris from bottom of inlet box
HEADWALL #1 (Concrete)	Between north entrance of Hawthorne Dr & Clubhouse Rd	Satisfactory	Photo 1	None

Photograph 9: Inlet #6

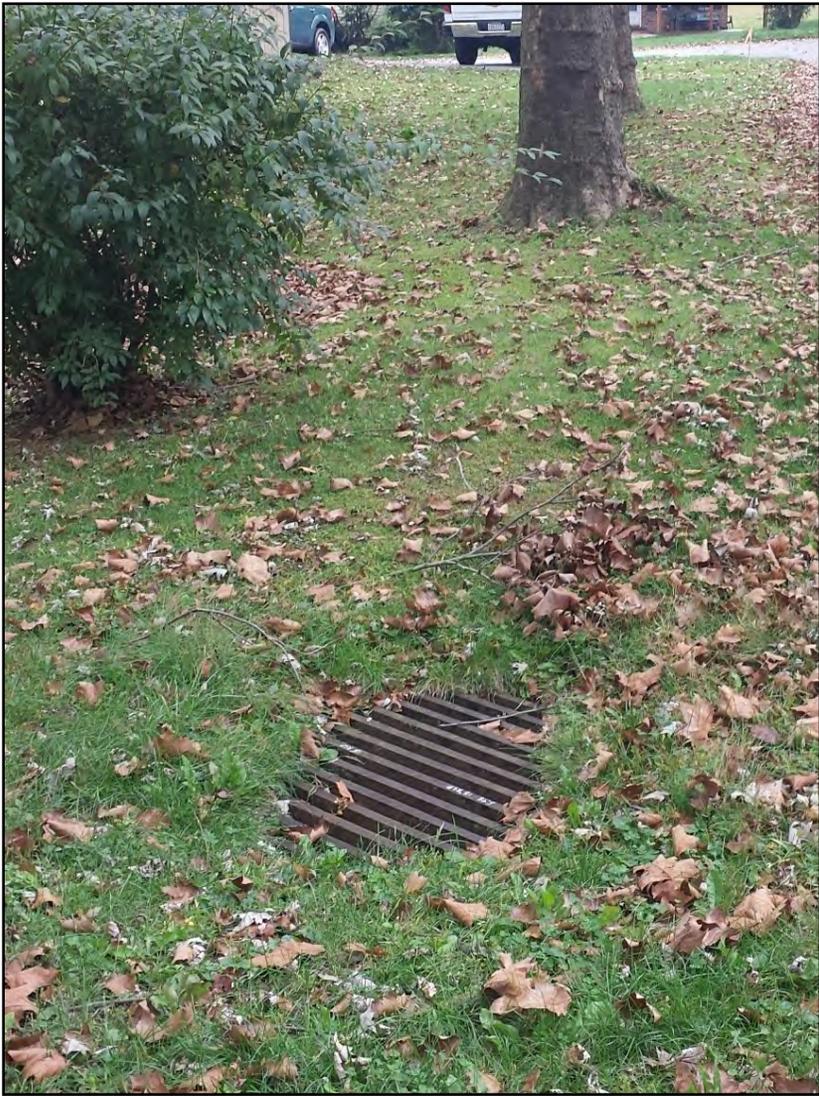
Photograph 10: Inlet #7

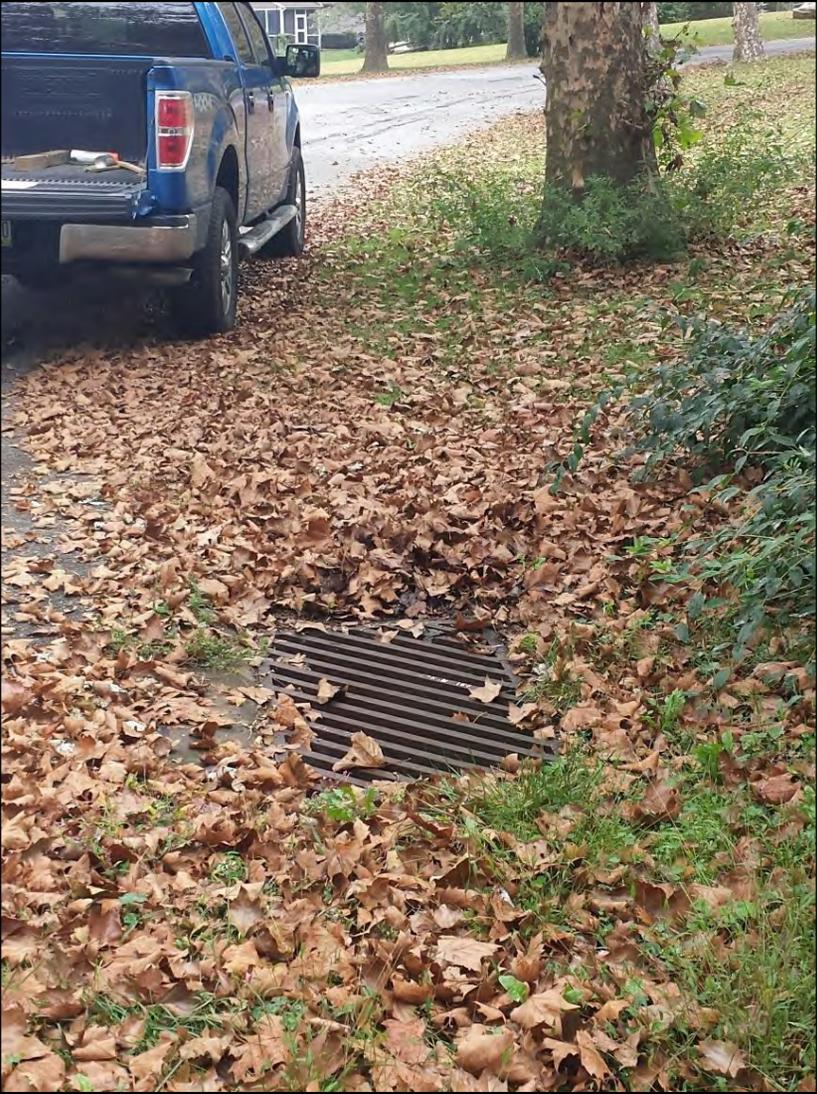
Photograph 11: Inlet #8

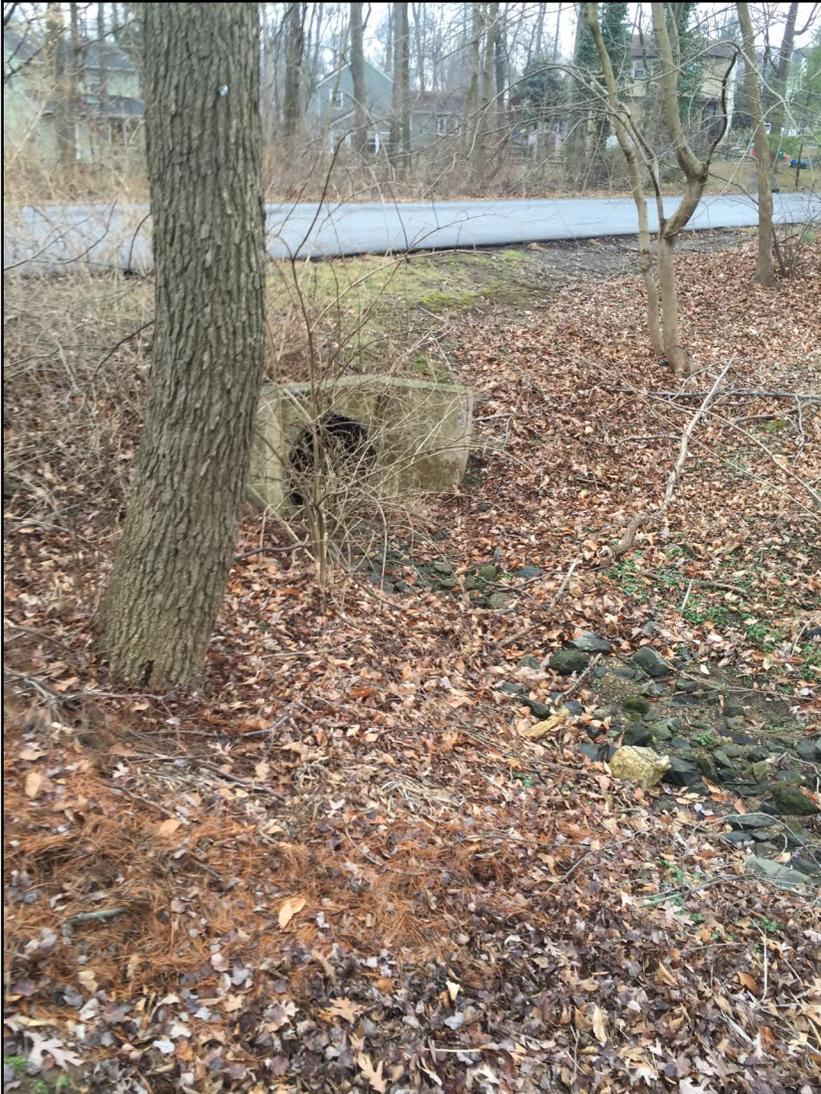
Photograph 12: Headwall #2

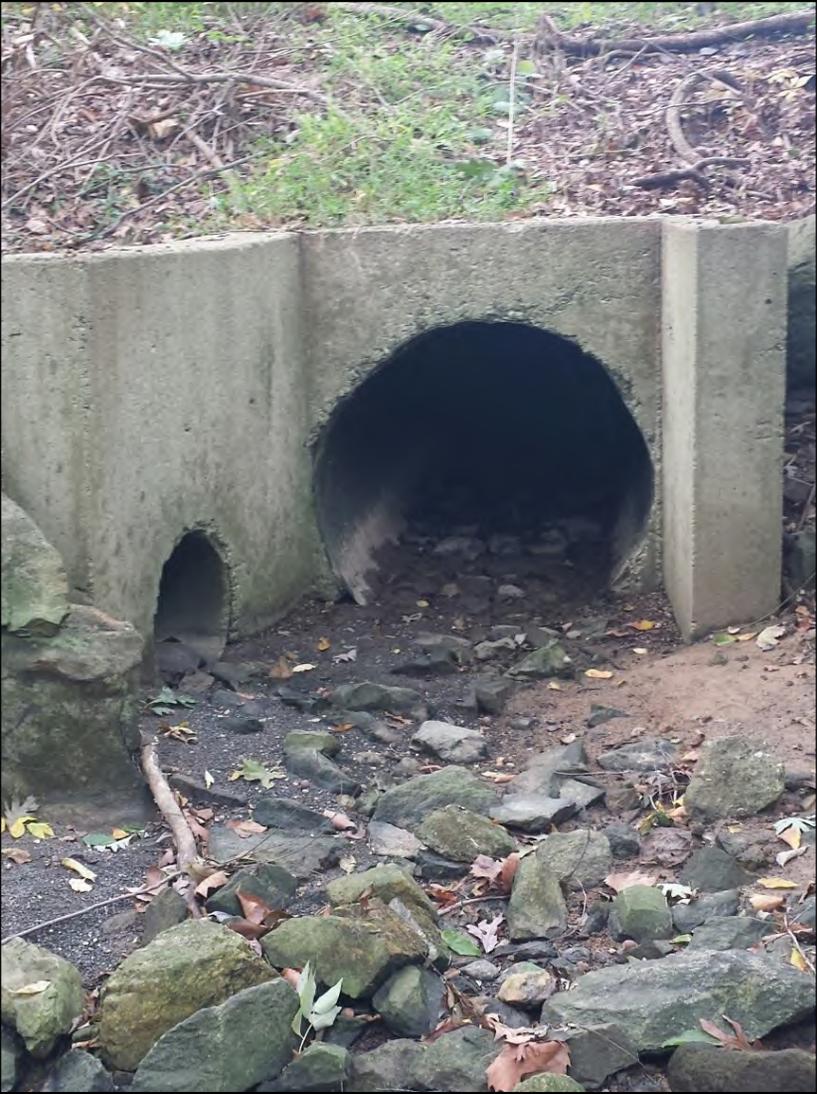
Photograph 13: Endwall #2

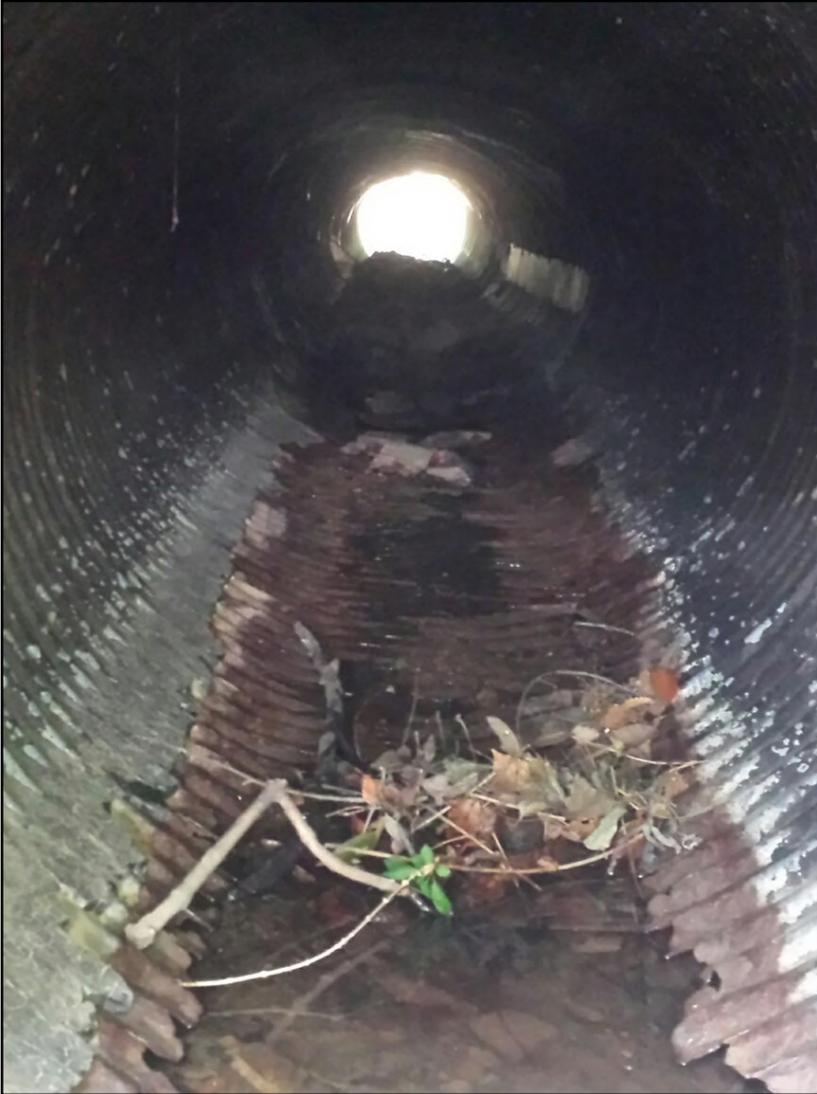
Photograph 14: 42" CMP between Headwall #2 and Endwall #2

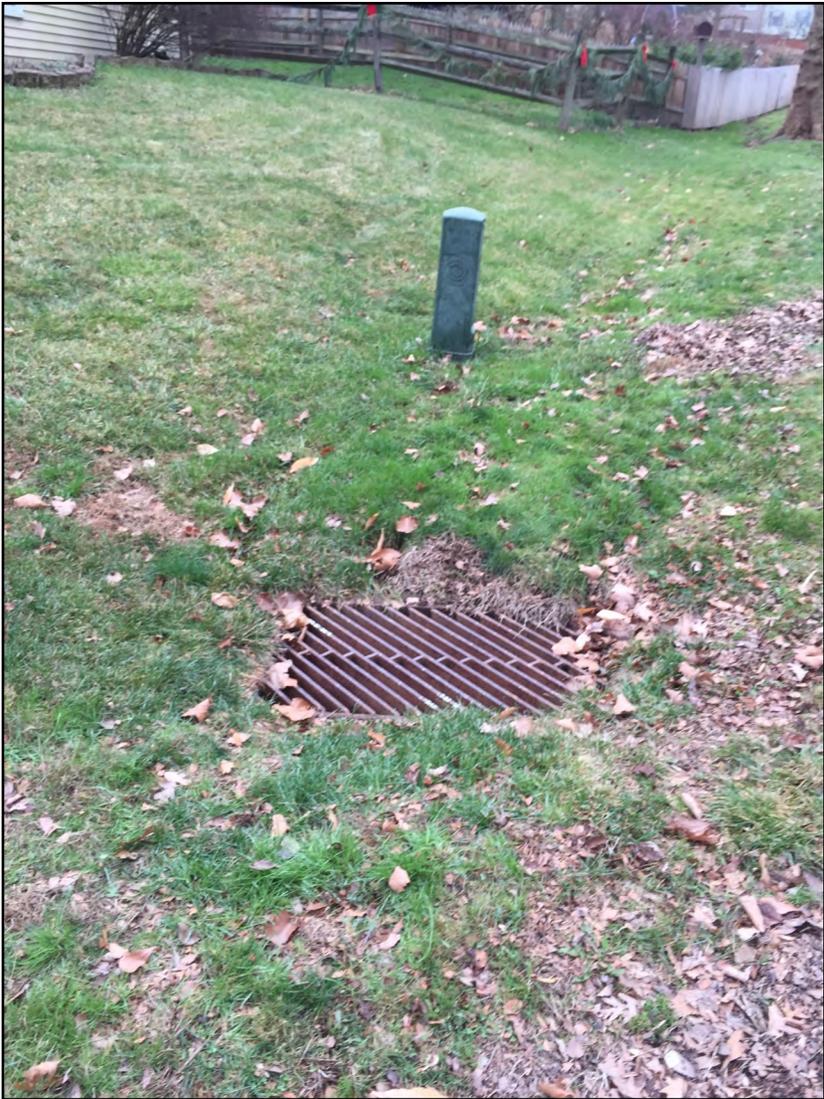
Photograph 15: Inlet #9

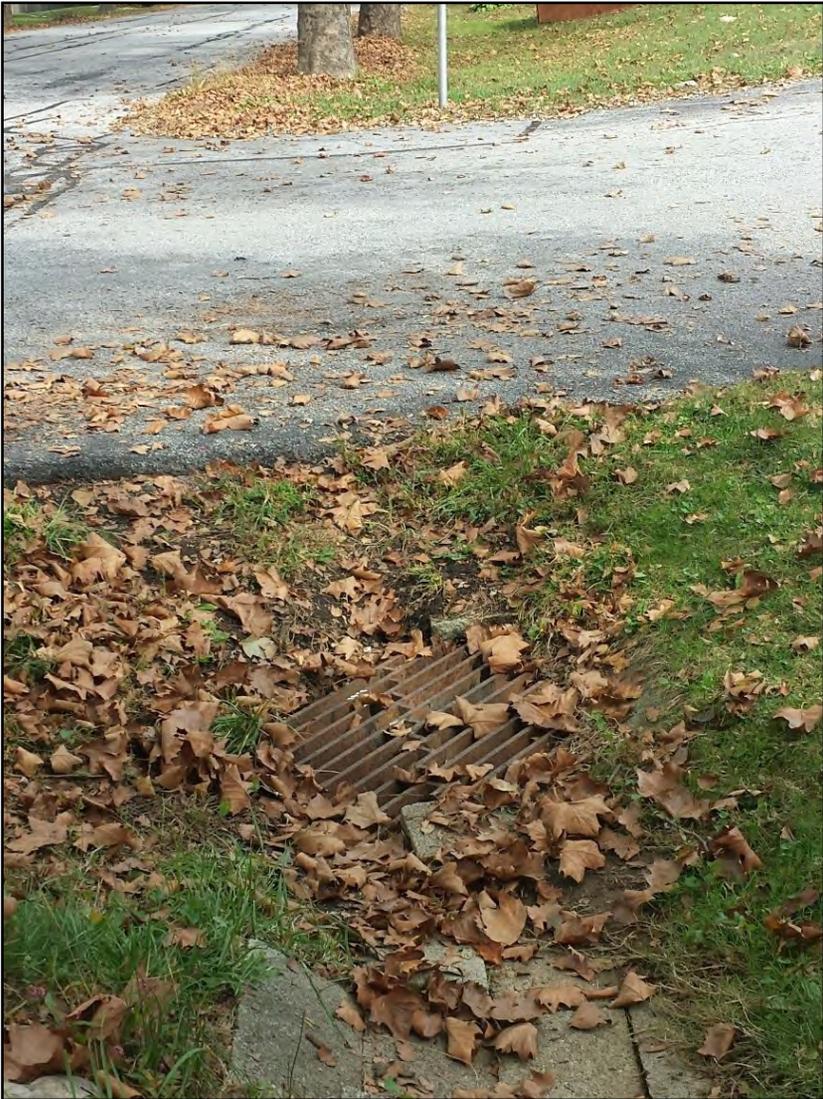
Photograph 16: Inlet #10

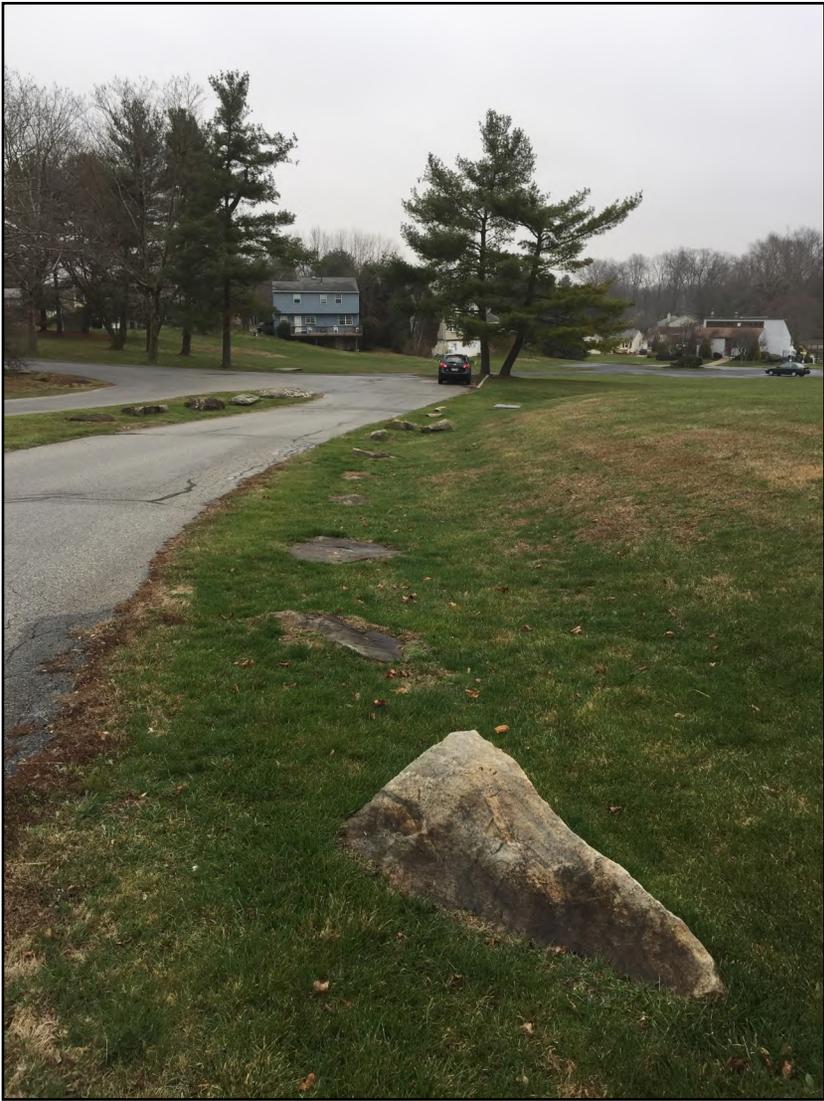
Photograph 17: Physical barrier of boulders within swale along eastern side of Hawthorne Drive from north entrance of Hawthorne Drive to Hedgerow Court

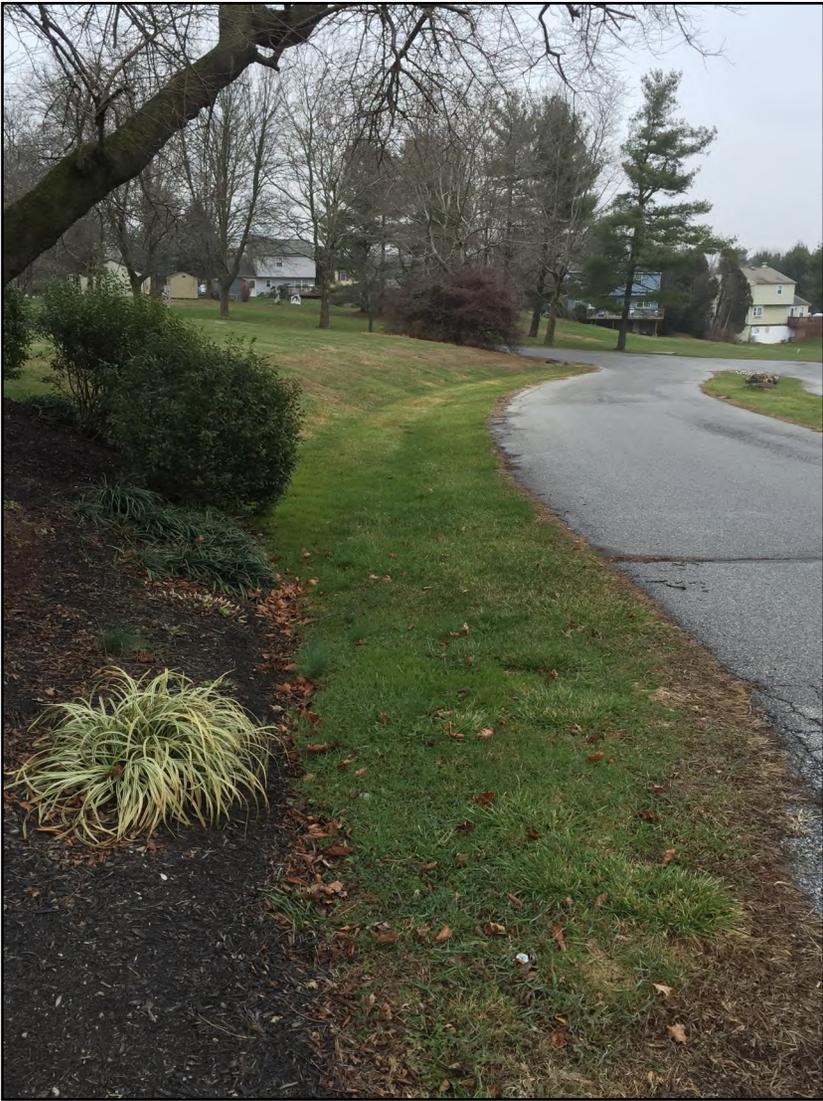
Photograph 18: Poorly defined swale along western side of Hawthorne Drive from north entrance of Hawthorne Drive to Hedgerow Court

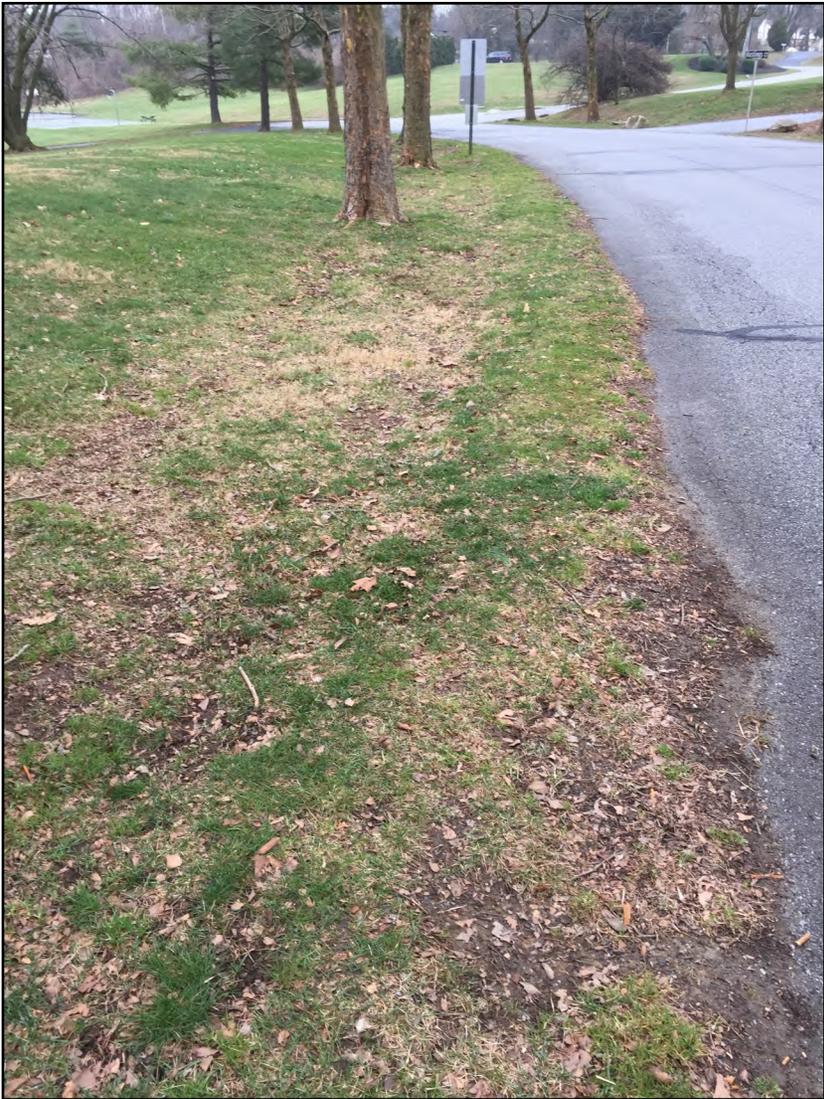
Photograph 19: Washout areas along the east side of Hawthorne Drive approaching Hedgerow Court.

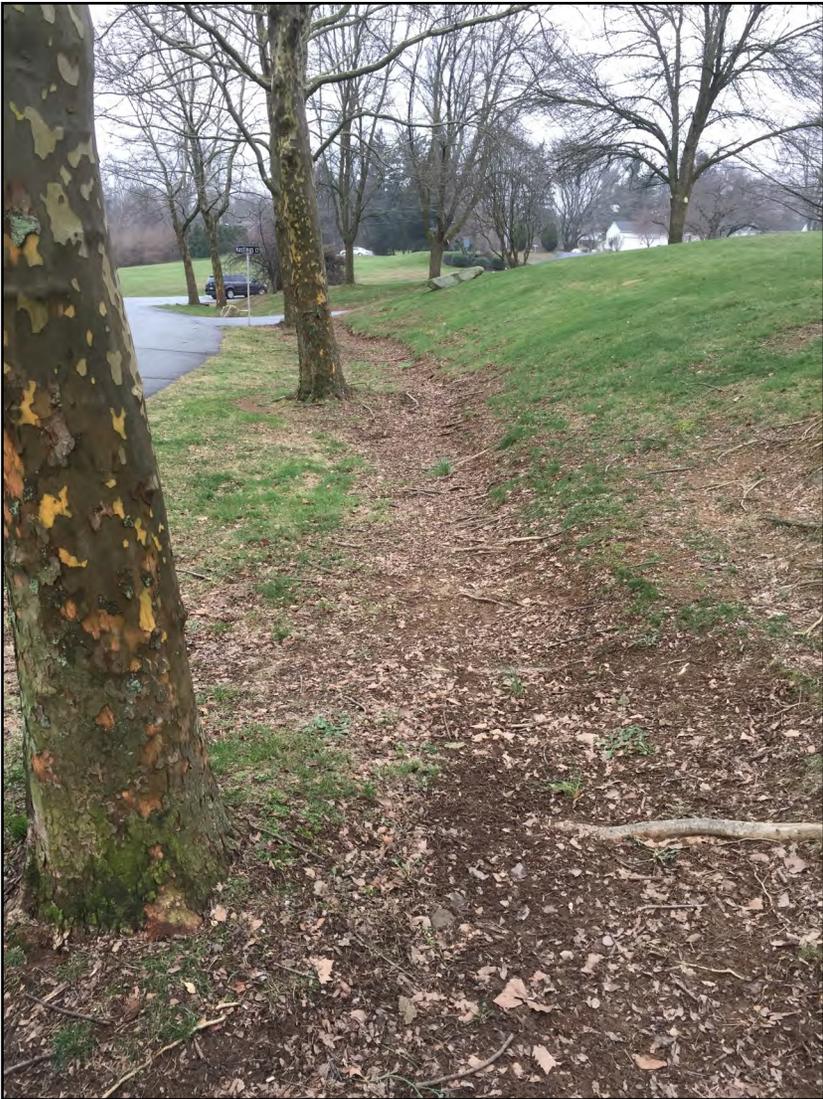
Photograph 20: Accelerated erosion along the west side of Hawthorne Drive approaching Hastings Court.

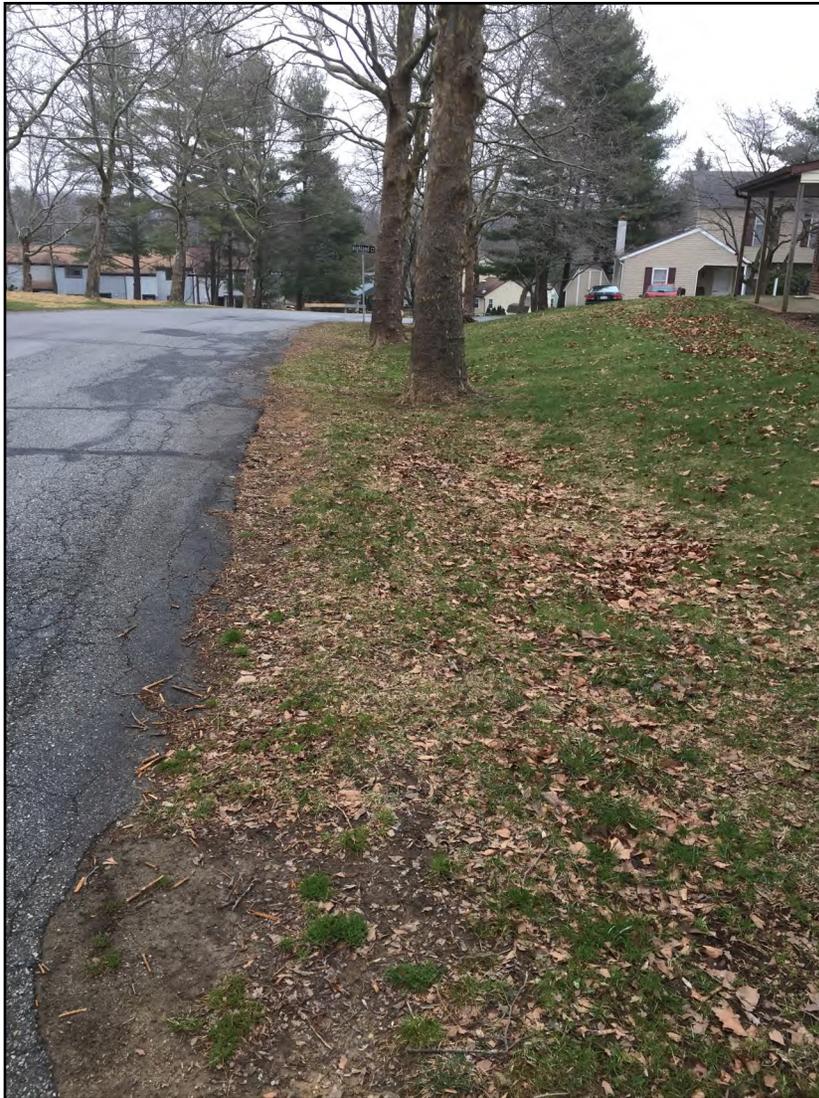
Photograph 21: Washout areas along the east side of Hawthorne Drive approaching Highland Court.

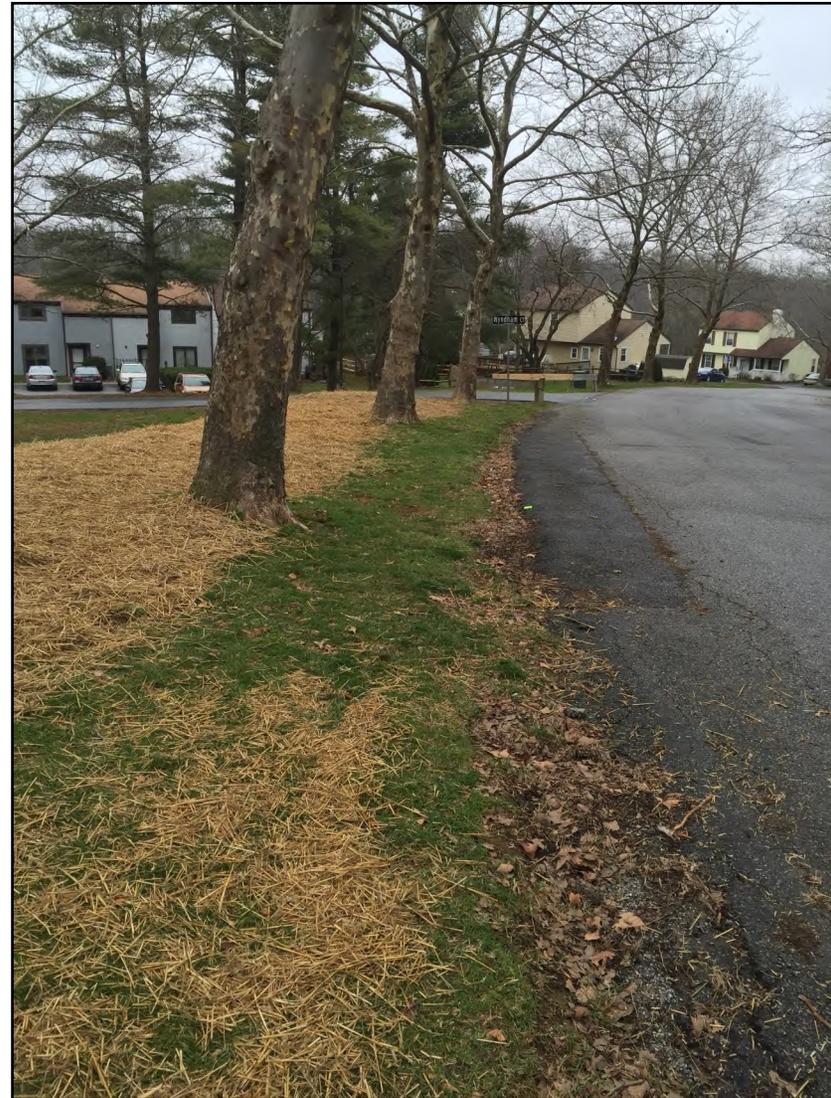
Photograph 22: Accelerated erosion along the west side of Hawthorne Drive approaching Wyndham Court.

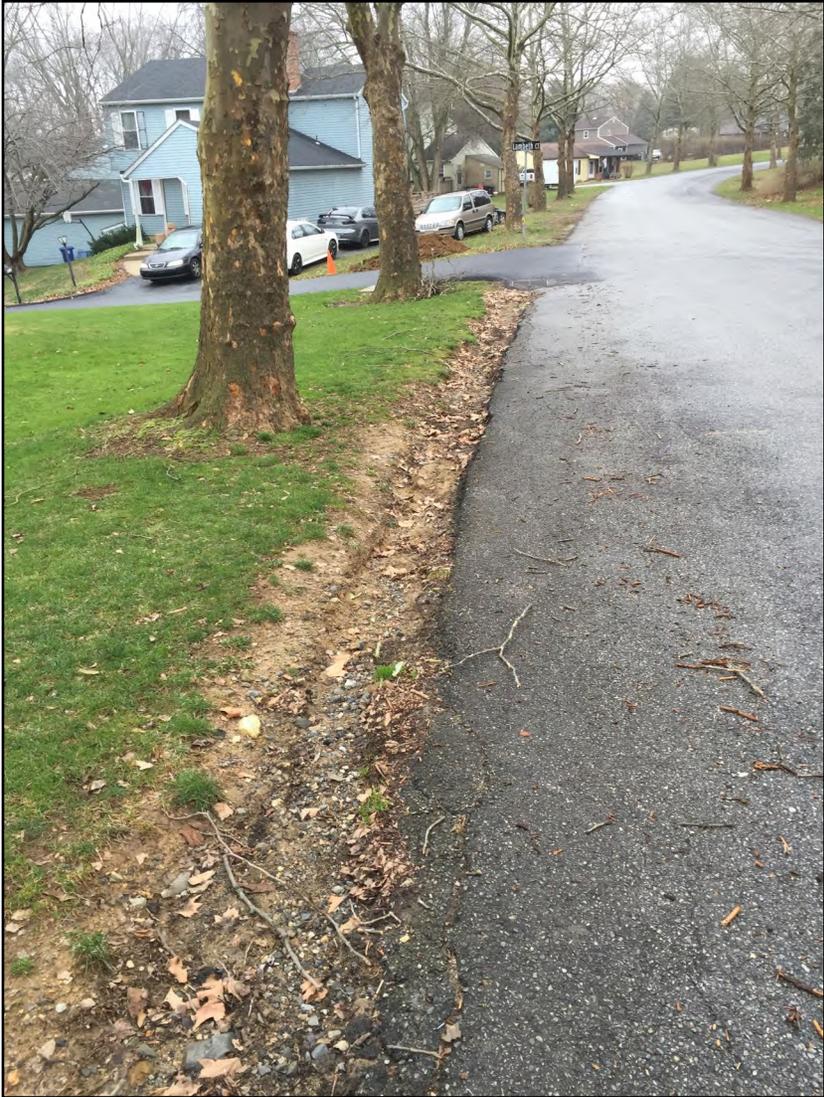
Photograph 23: Accelerated erosion along the north side of Hawthorne Drive approaching Lambeth Court.

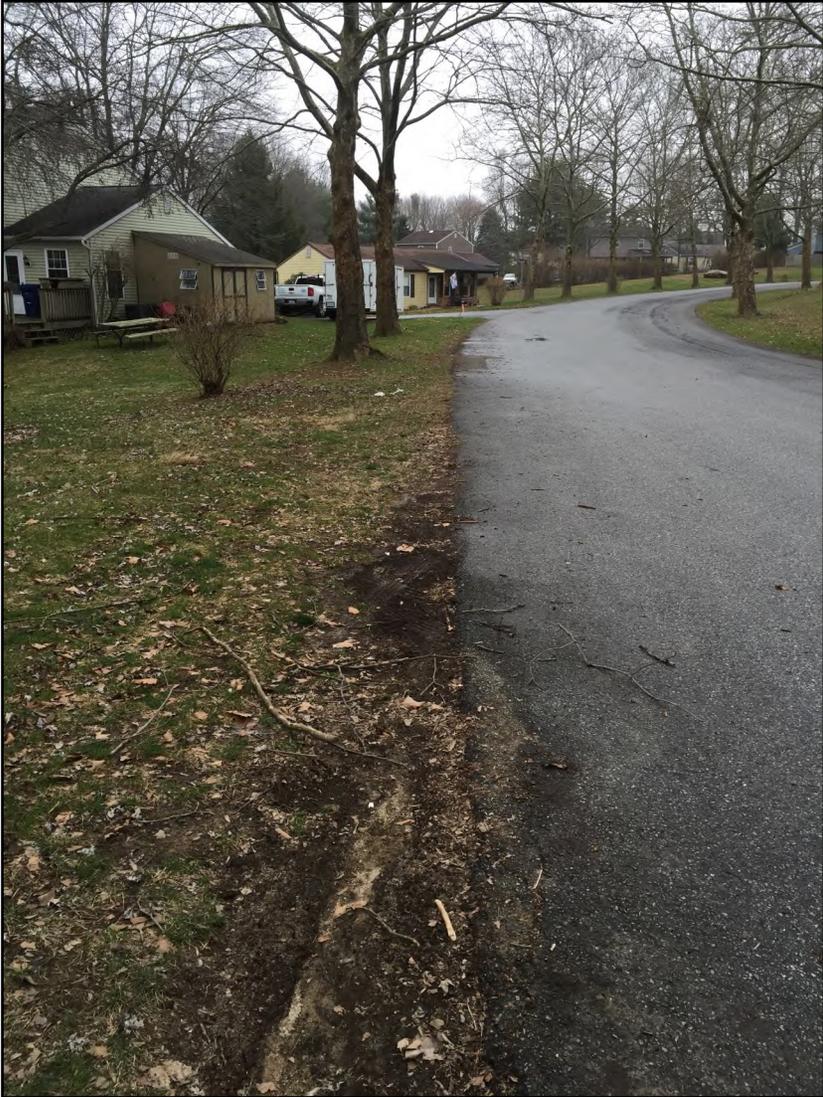
Photograph 24: Washout area along the north side of Hawthorne Drive approaching Chapel Court.

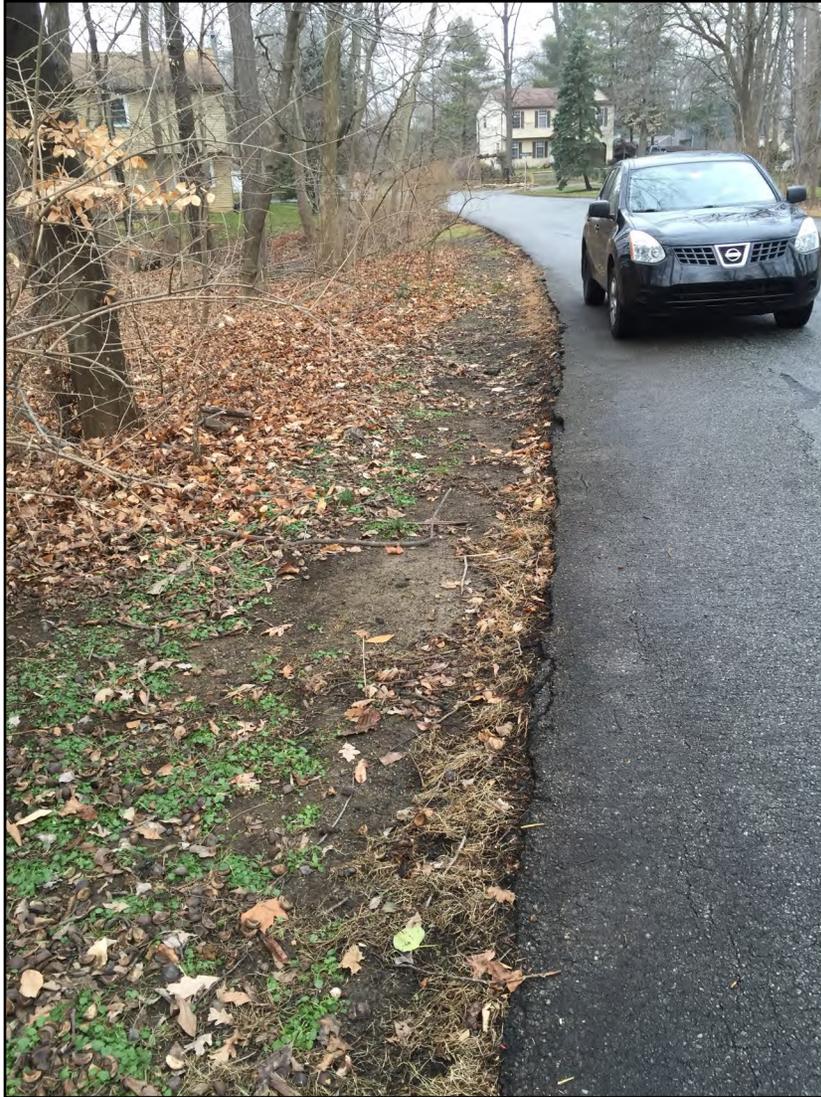
Photograph 25: Accelerated erosion along the west side of Hawthorne Drive approaching Headwall #2.
