HAWTHORNE DRIVE COMPREHENSIVE STORMWATER MANAGEMENT STUDY

February 29, 2016

East Brandywine Township
1214 Horseshoe Pike
Downingtown, PA 19335

EXECUTIVE SUMMARY

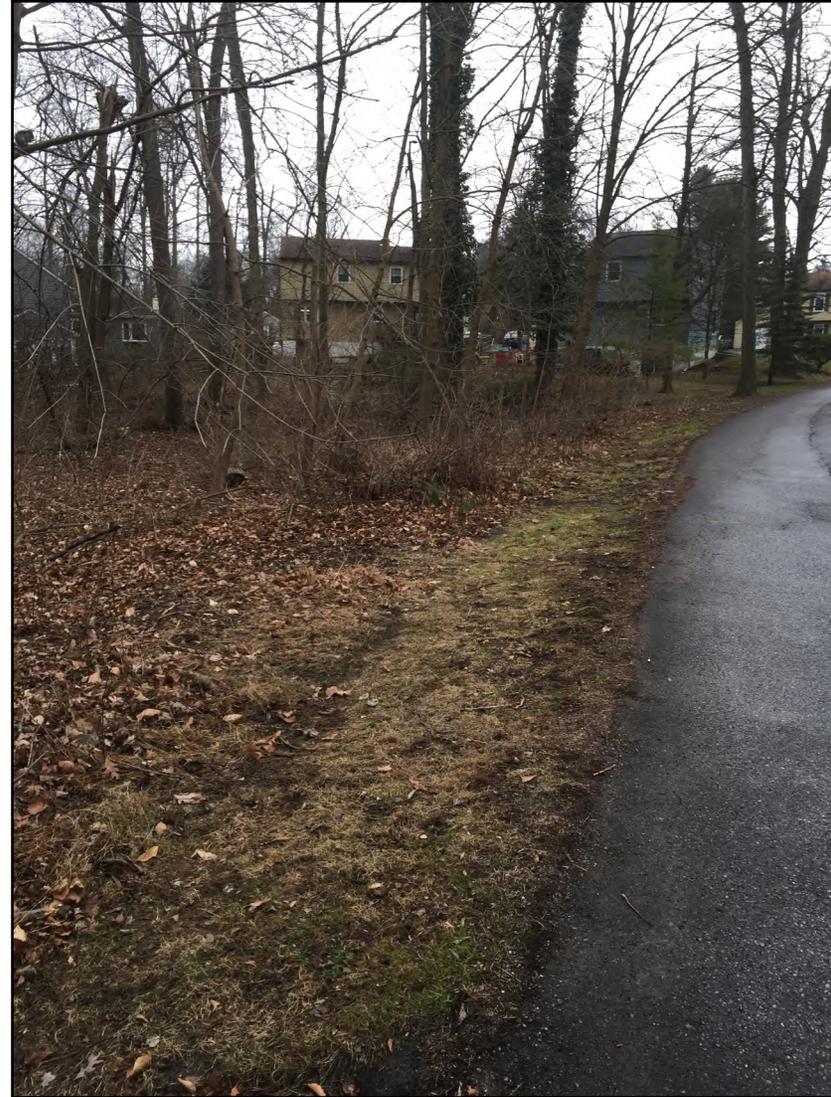
Photograph 26: Washout area along the east side of Hawthorne Drive approaching Endwall #2.

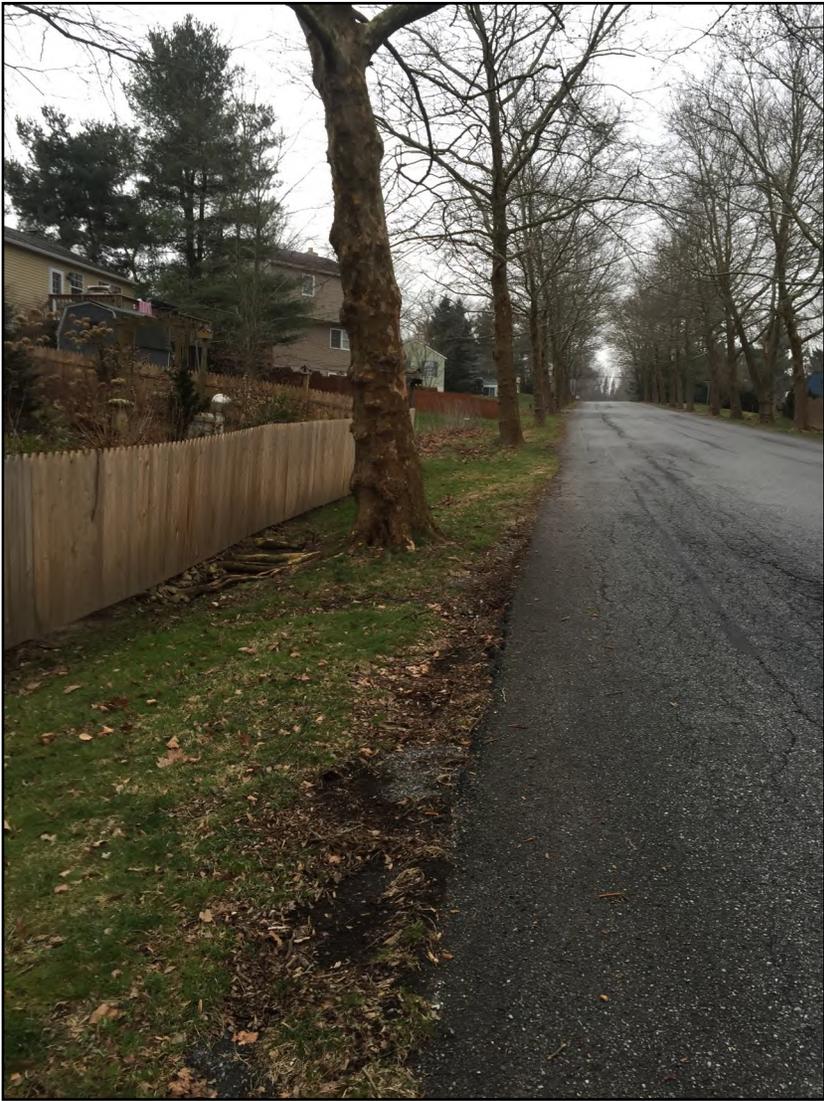
Photograph 27: Surface tree roots blocking existing swale along the west side of Hawthorne Drive approaching Somerset Court

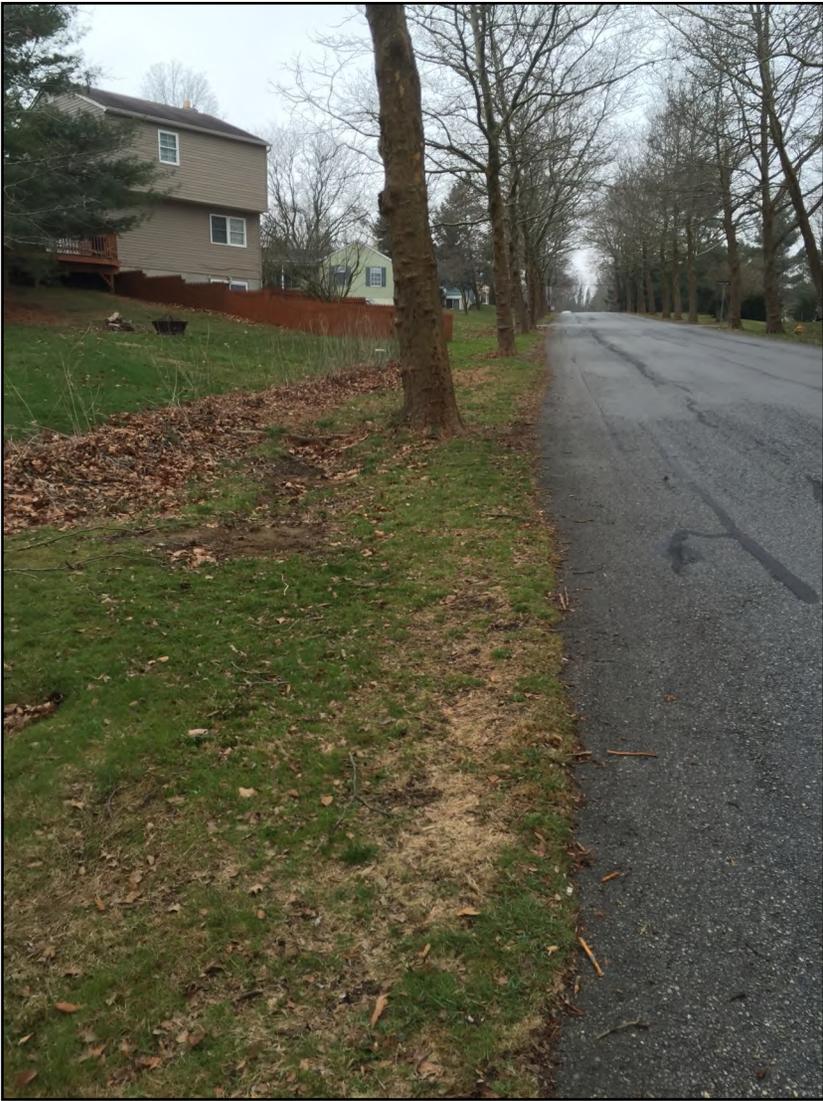
Photograph 28: Washout area along the east side of Hawthorne Drive approaching Canterbury Court

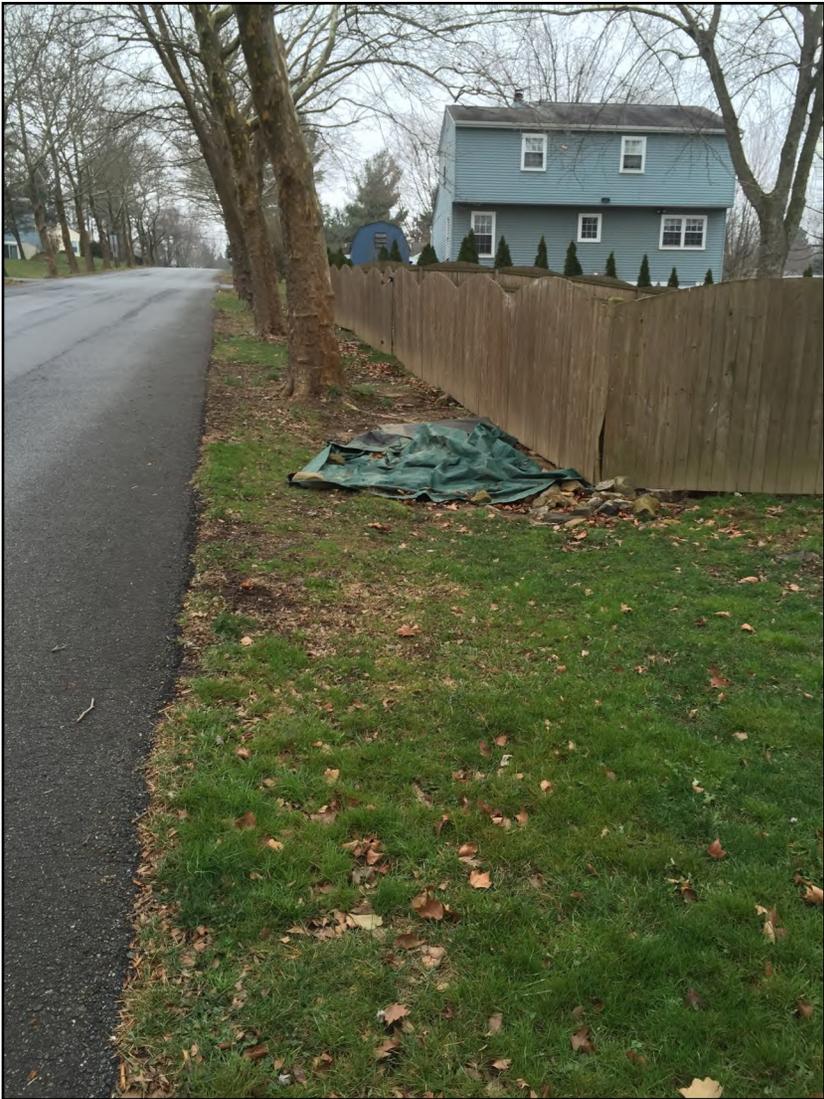
Photograph 29: Debris/trash blocking existing swale along the west side of Hawthorne Drive approaching Somerset Court

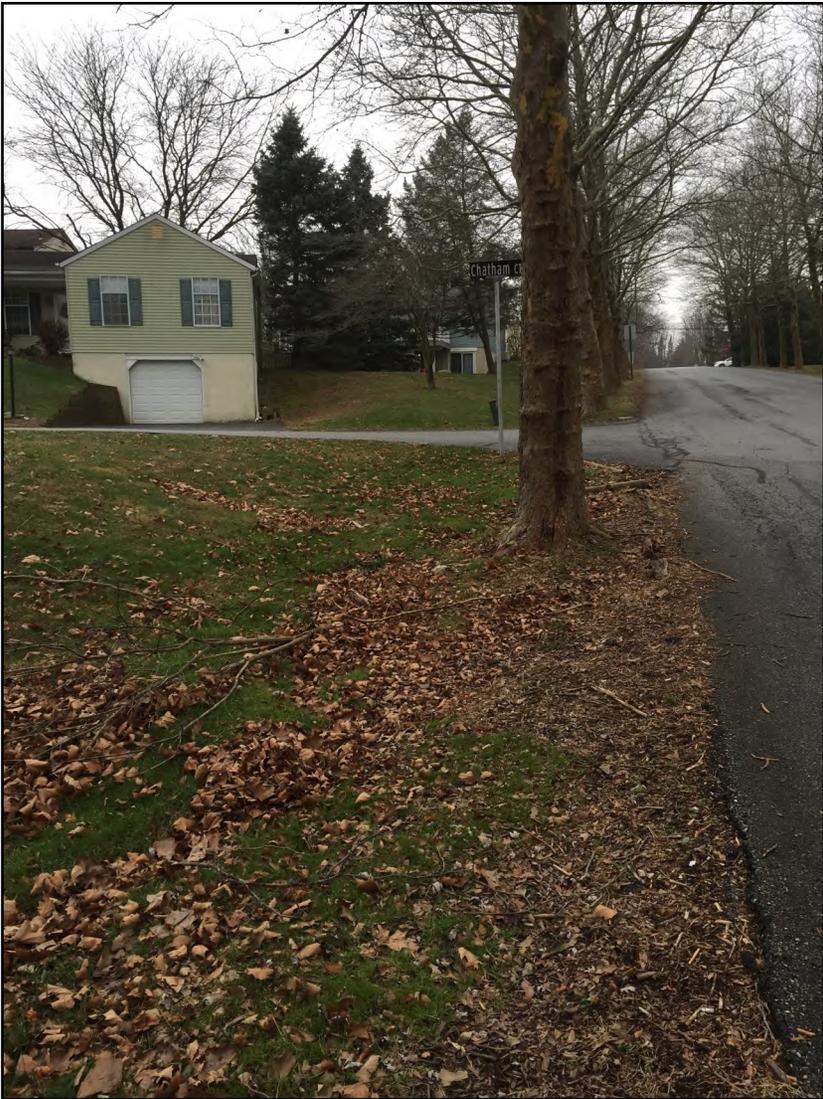
Photograph 30: Washout area with debris along the east side of Hawthorne Drive approaching Chatham Court

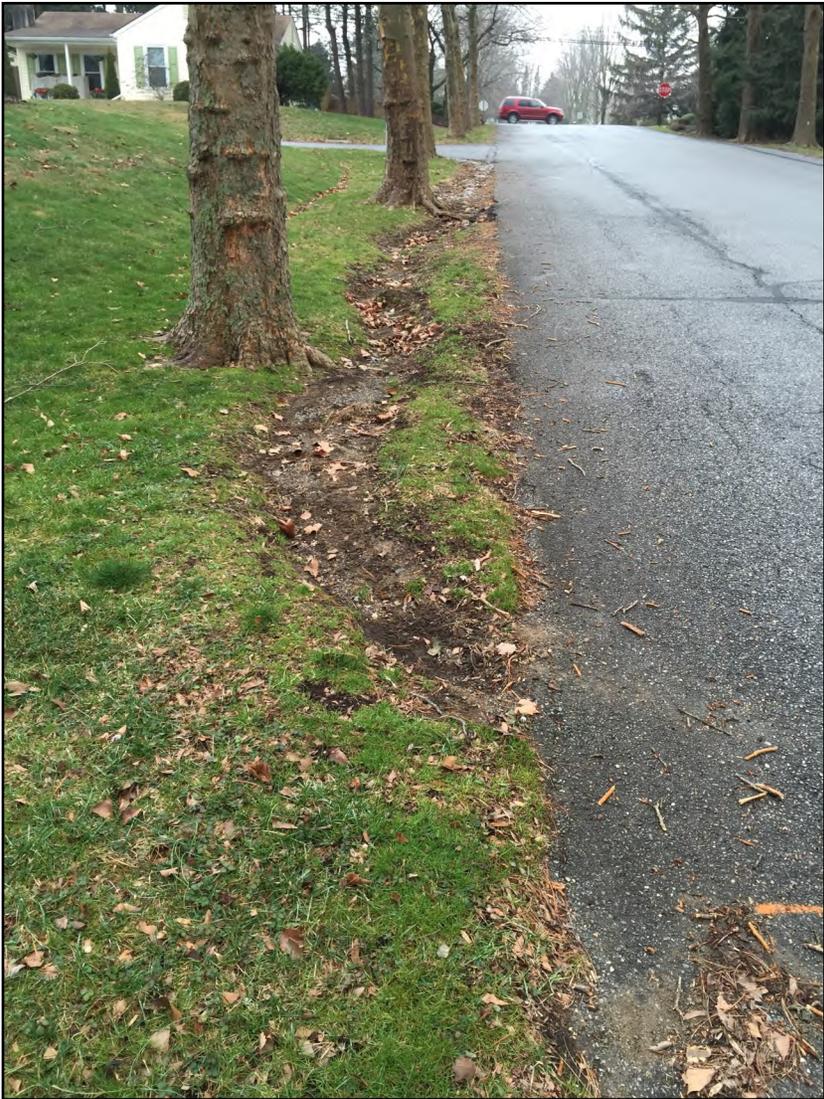
Photograph 31: Accelerated erosion along the east side of Hawthorne Drive approaching Essex Court

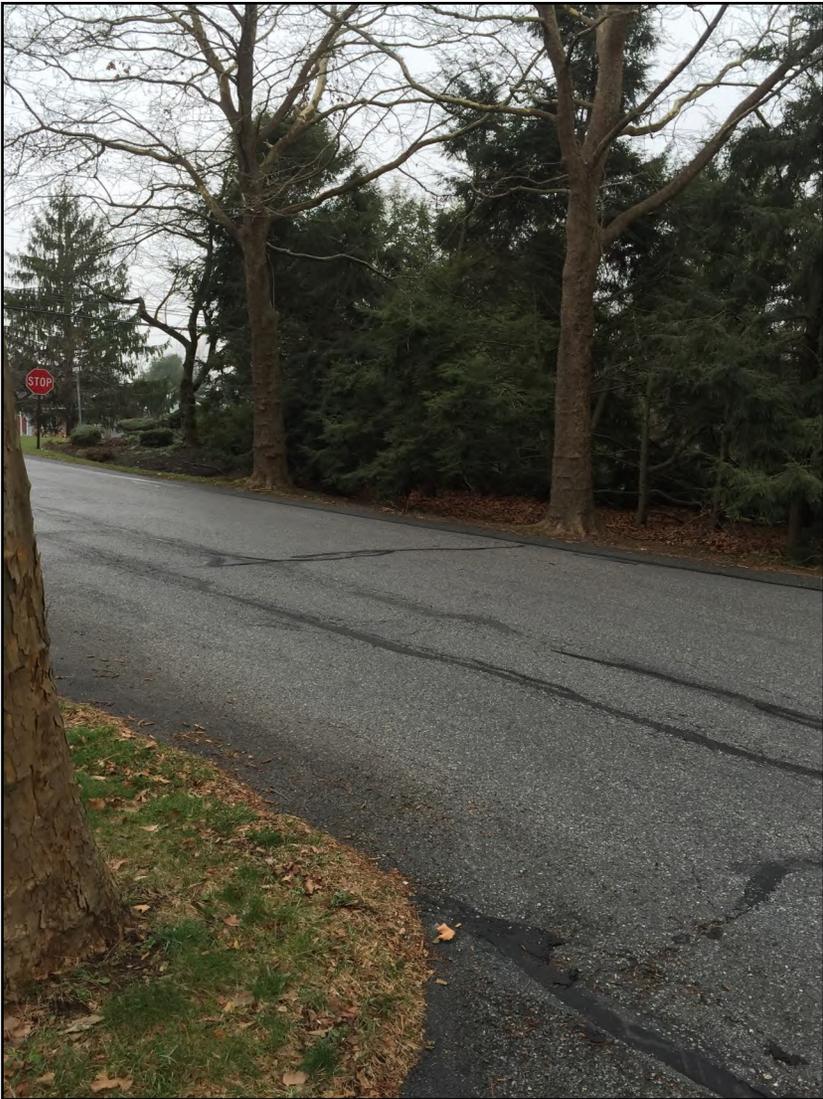
Photograph 32: Poor condition trees along the west side of Hawthorne Drive approaching south entrance of Hawthorne Drive

For all trees classified as Fair or Poor, it is recommended that these trees undergo treatment, pruning, or preemptive removal.
