HISTORIC RESOURCE REPORT

PRELIMINARY FINDINGS

BONDSVILLE MILL

December 20, 2006

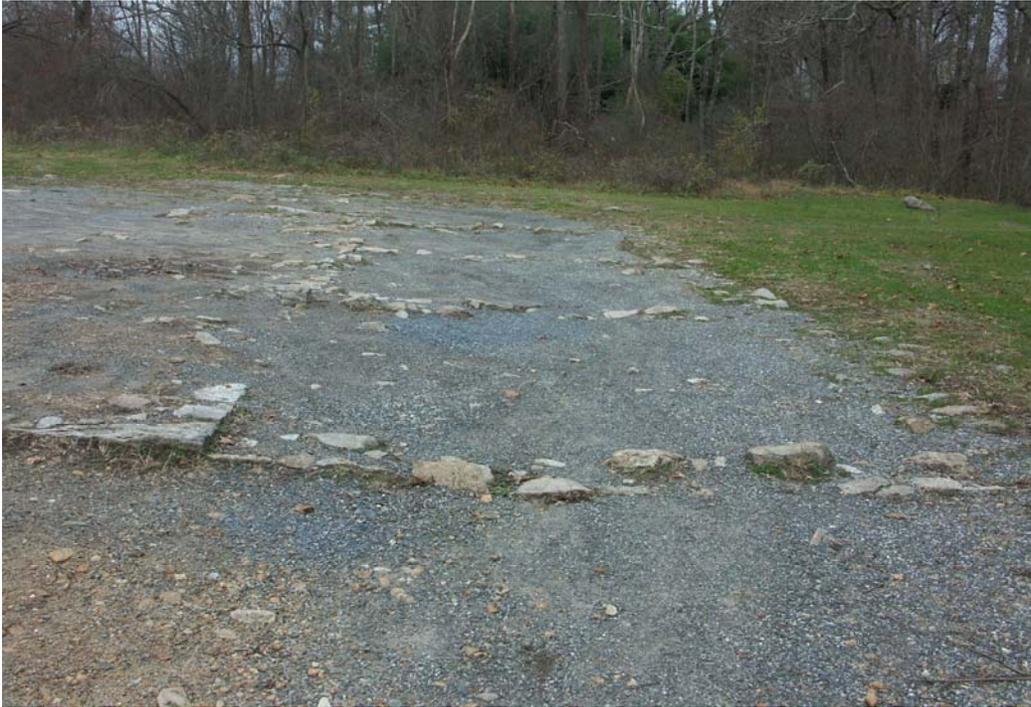
Photo 1. Photo of the foundation ruins of the mill workers' houses on the northeast side of the road, currently the parking area.

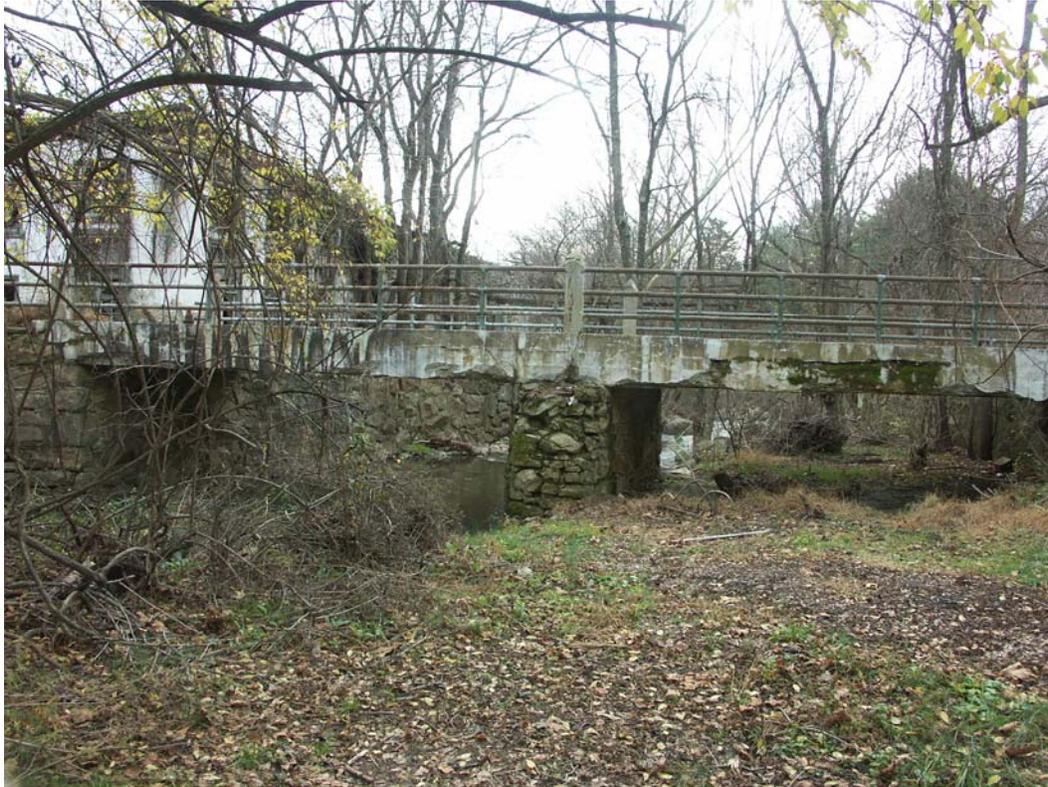
Photo 3. Main Bridge, facing southeast. The northwest corner of the mill is visible on the left.

The mill complex connects to Bonds Mill Road by two bridges spanning Beaver Creek. The western, or main, bridge is the primary access to the mill. It has long stone abutments and wing walls which incorporate the stone wall system along the creek. It is a continuous span bridge with a mid-20th century decking. (A photograph taken c. 1890 shows a smaller bridge with a king’s post truss suspension system spanning the creek. See Figure 3.) Concrete balusters with pyramidal caps line the sides of the cartway and are connected by iron railings. A centered, rubble stone pier stands on the west side of the creek.

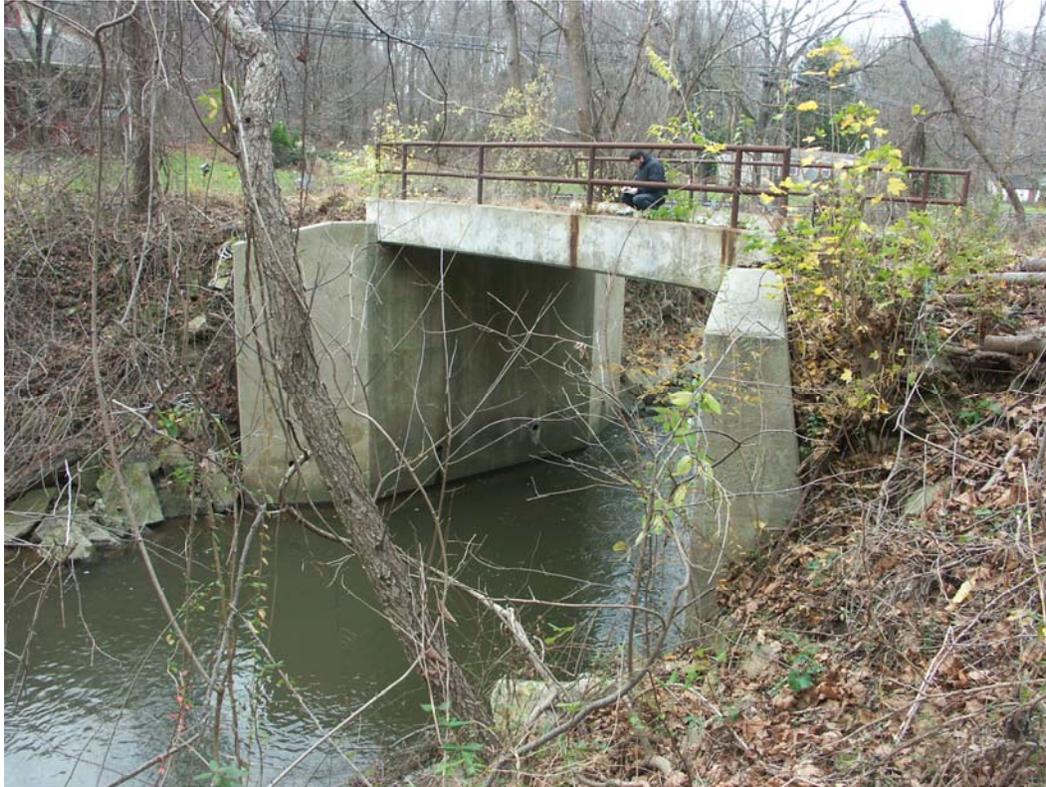
Photo 4. New Bridge, facing northwest.

The New bridge over Beaver Creek is located south of the mill. A lane leads across the bridge, then angles north to the mill complex and runs northeast of the mill. The bridge is a single span concrete structure. The abutments, wingwalls, and the cartway are reinforced concrete. An iron pipe railing lines the sides of the bridge. This bridge appears to have replaced an earlier bridge in this location.

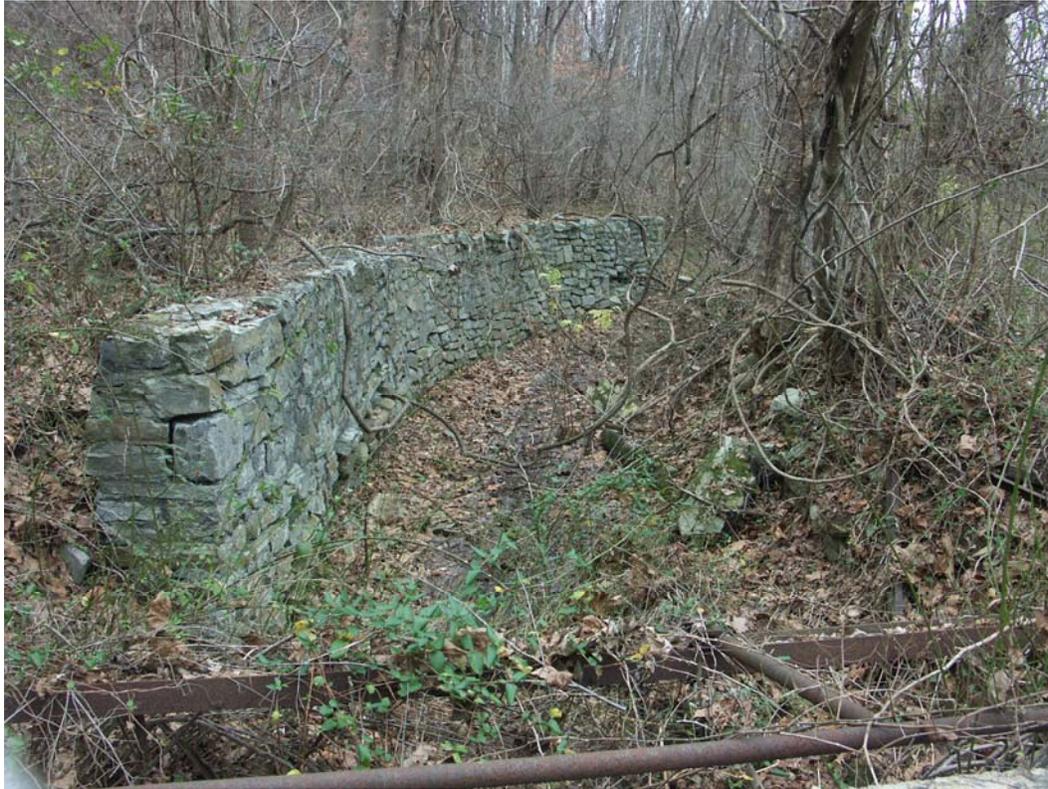
Photo 5. Stone wall lining the old mill race, facing southeast.

An old mill headrace is located northwest of the mill site. The headrace, now dry, originally carried water from the mill pond (northwest of the current property) to the northeast side of sections A-C of the mill. The headrace is mainly lined with earth banks, although the portions lined with stone have some of the finest stonework on the mill site. A small stone bridge leads over the mill race near its northern terminus to the ruins of a garage. The race arcs southeast and ends in a small square area north of Section C of the mill.

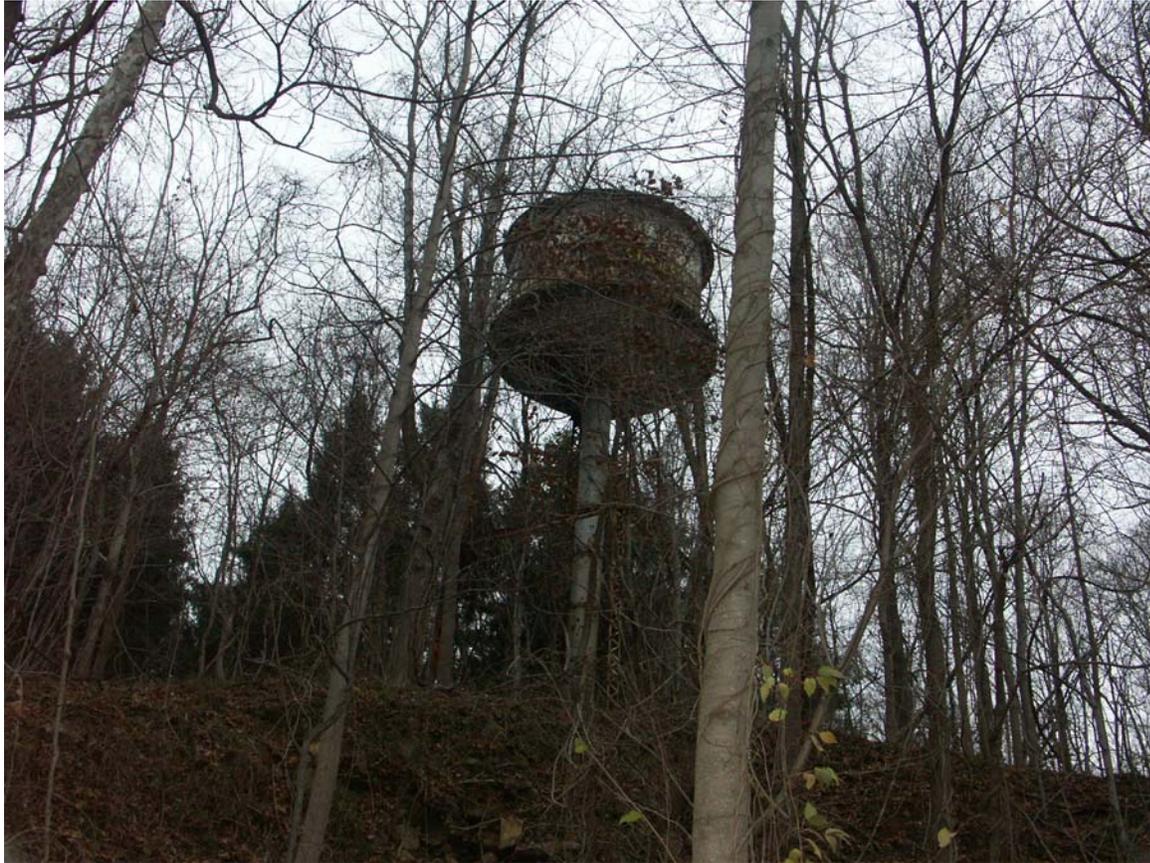
Photo 6. Water tower, facing northeast.

The water tower is located northeast of the mill ruin. The topography rises northeast of the mill, and the tower stands on a small plateau 30 feet above the grade of the mill. The gravity feed water tower consists of a reservoir supported by four cross-braced steel legs and the central pier. It rises to a height of approximately 45 feet. A valve to control the water is located on the northeast side of the mill and is pictured here. The valve is set at “open” currently.

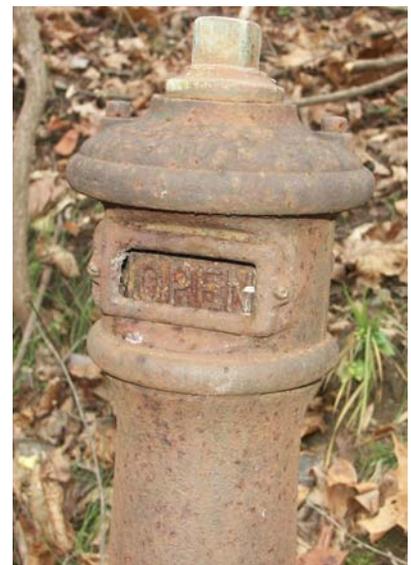
Photo 7. Water valve, facing northeast. This valve was used to control the flow of water to the mill.

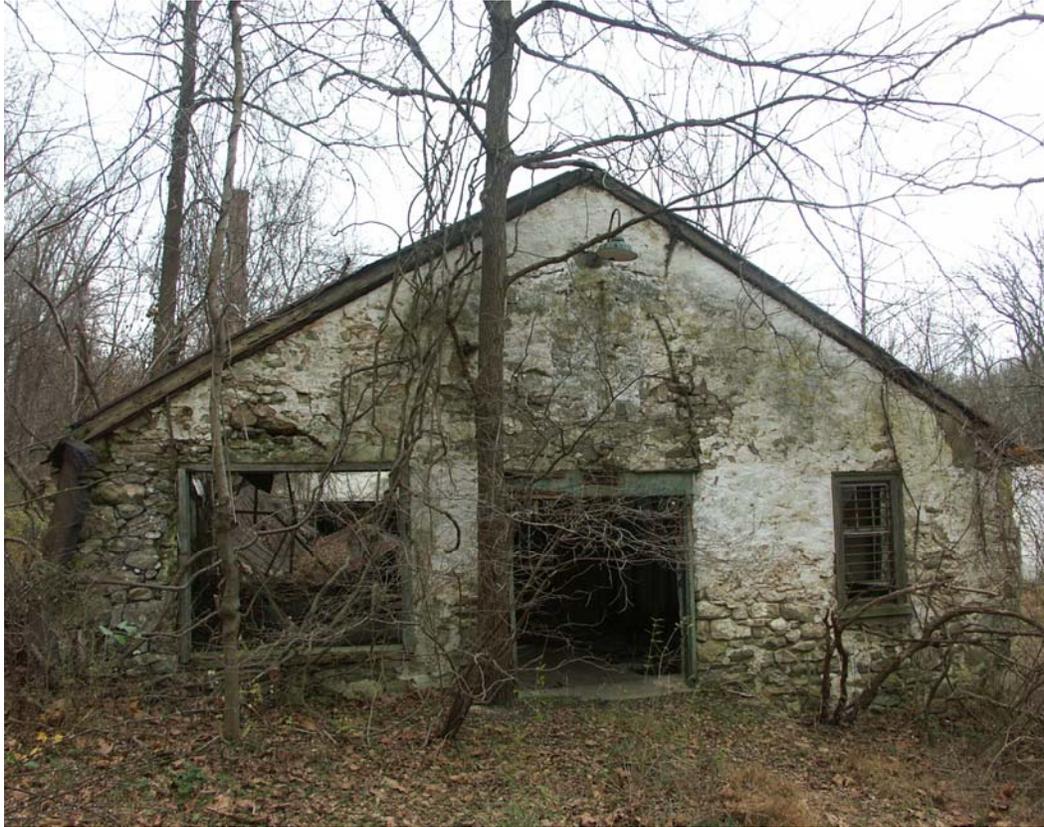
Photo 8. Northwest end wall of Section A.

Section A is a two-story, four-bay stone bank section on the north end of the mill complex. It is one of the earliest sections of the mill and was used for storage of finished material in the mid-20th century. The building measures approximately 30'x50'. It opens onto grade on two elevations, with the upper level accessible on the northwest elevation (shown here) and the lower grade opening into the southwest side elevation. The section has a standing seam tin roof which remains in place but is in failing condition. The stone walls are partially stuccoed, which has helped maintain the structural integrity of the walls. The northwest end wall has a wide overhead garage door between two windows; the window to the left is a greatly enlarged window in poor condition, and the window to the right is a replacement 1x1 double hung sash window in failing condition. The roof slopes down to grade on the northeast elevation. The southwest elevation has four second floor windows, all in failing condition, over a first floor window band.

Section A condition: Poor. The roof is failing, which is allowing the interior framing system to deteriorate. Water infiltration is a growing problem. Wall openings are in poor condition, and the stucco is progressively failing. Much of the interior plasterwork has failed, partially in conjunction with the failure of the roof of Section B. Water infiltration precipitated a failure of the framing system in the northwest corner also, where a large hole is evident in the floor.

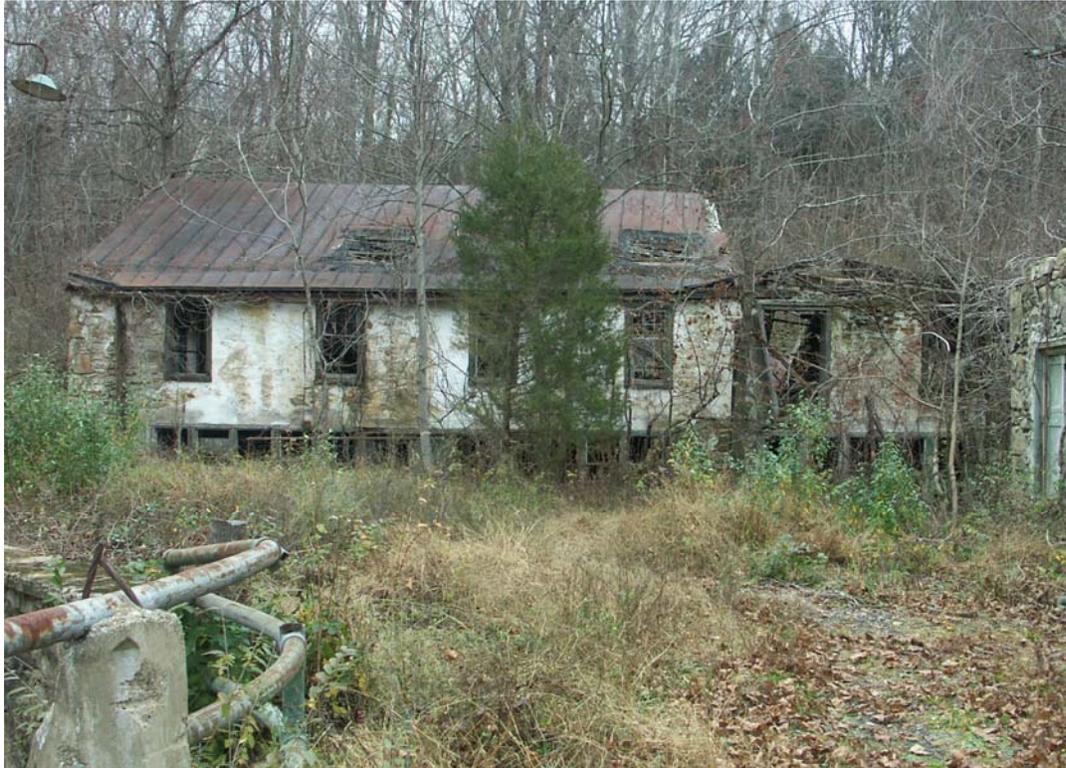
Photo 10. Section A (stuccoed, left), and Section B (stone ruin, right), as viewed from the Main Bridge.

Section B measures approximately 30'x50'. It was a two story bank building, four bays wide. The section is in poor condition, resulting from the collapse of the roof and interior framing. The stucco-over-stone walls are also in poor condition. Little remains of the windows; few frames and panes are extant. Like Section A, a window band is located on the southwest elevation which was used to naturally light the storage areas there in the mid-20th century.

Section B condition: Ruinous. The section is entirely unsafe due to the total failure of the roof and interior framing system.

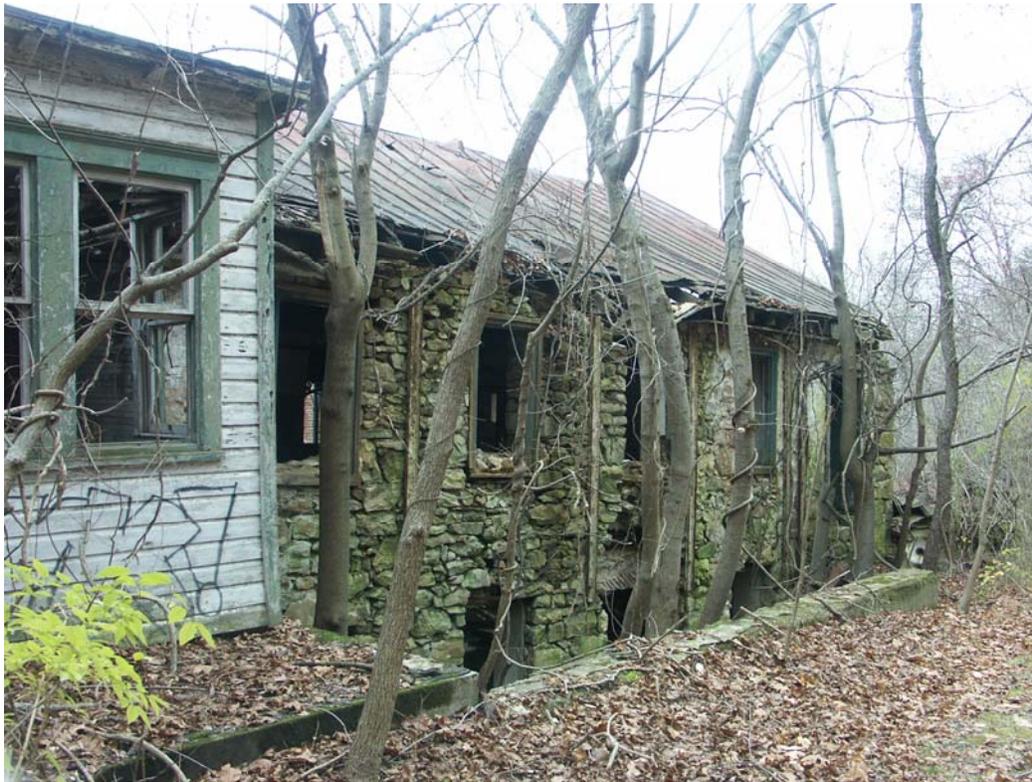
Photo 11. Section C, rear elevation. Trees are growing out of the mill race between the mill and the stone retaining wall.

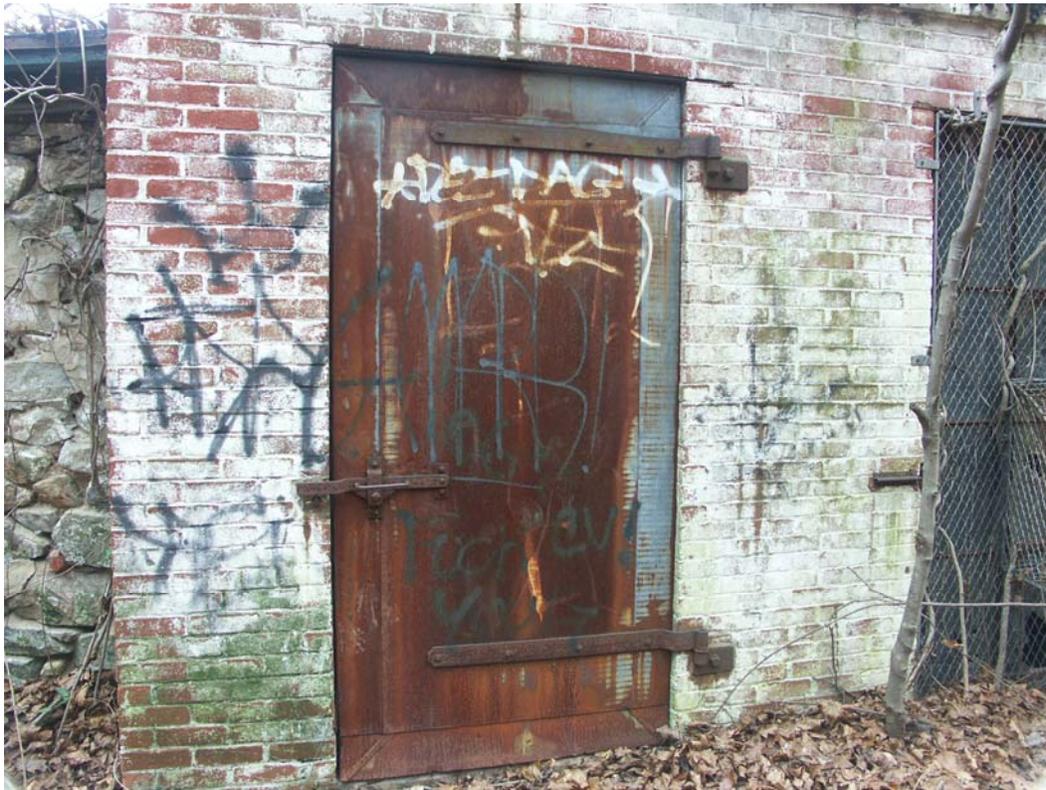
Photo 12. View of the main elevation of Section E, showing the heavy metal door in the brick wall.

Sections D and E condition: Poor to Ruinous. Both sections exhibit structural failure, although the walls have not collapsed and the roof is somewhat intact. Due to the roof height and other concerns, this area is highly dangerous to enter.

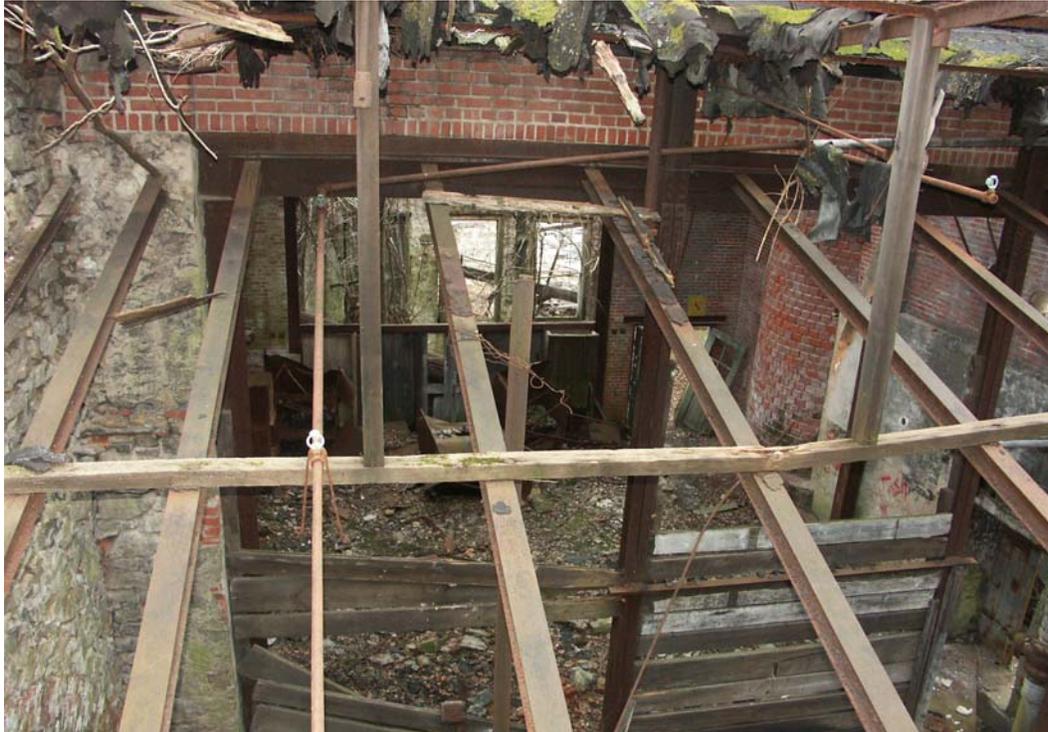
Photo 13. View of the interior of Section E, facing southwest from a point on the hillside.

The brick walls of the space have some interesting features. The southwest wall of the boiler room has a large opening which looked out into the interior of Section H, the main section of the mill. This opening is lined with steel I-beams. A double “man door” located near the round chimney opens into the main section of the mill complex. The northwest wall, which is the party wall with Section D, has a steel I-beam installed vertically; it may have been installed to help hold the brick wall in place and prevent or discourage corbelling or horizontal settling of the stone walls.

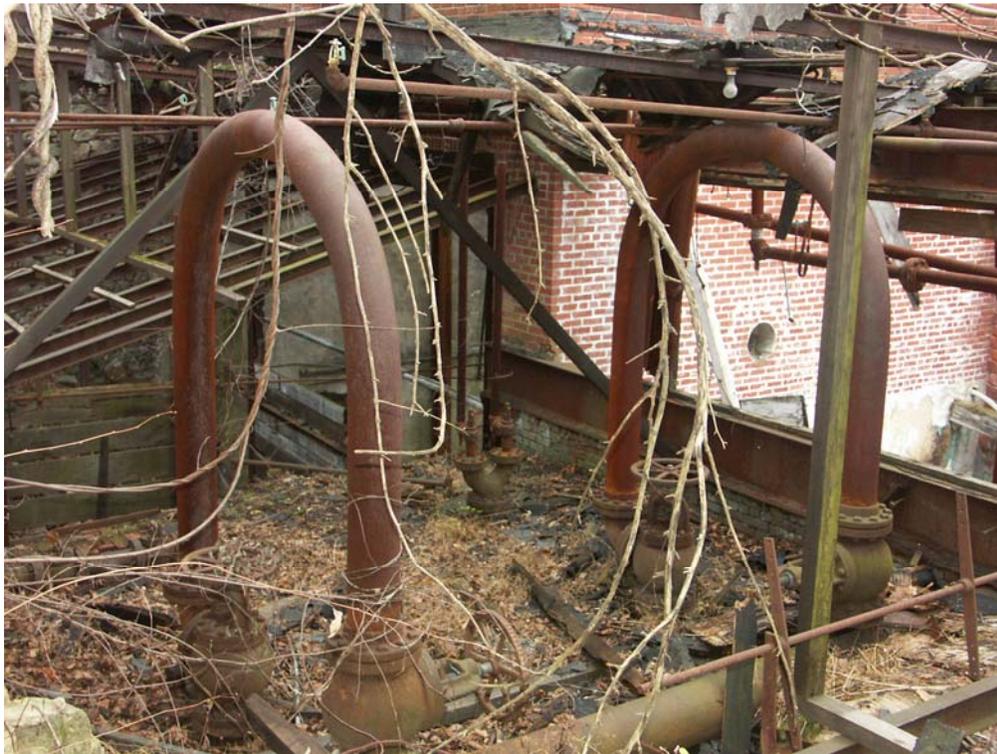
Photo 16. Steam pipes, boiler, located in Section D.

The interior of Section D was not accessed due to poor building condition. Large pipes and control valves for the steam works are located here, just northwest of the boiler in Section E. Also located here is the large square brick chimney remaining from the steam powerplant of the 1870s.

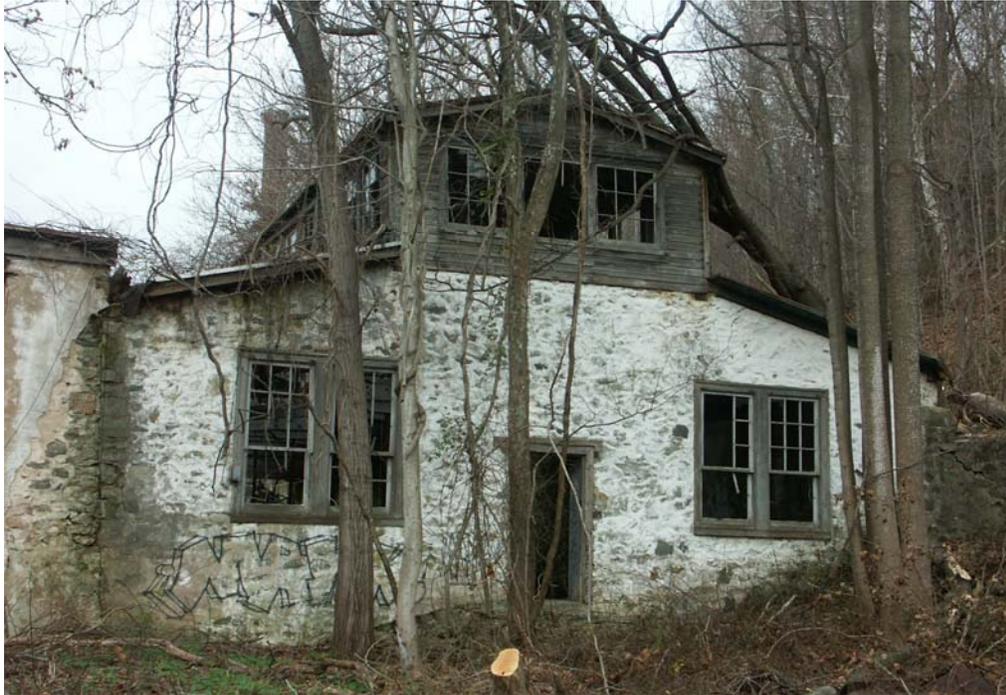
Photo 17. Section F, facing northwest. Note the monitor roof, which runs the length of the section.

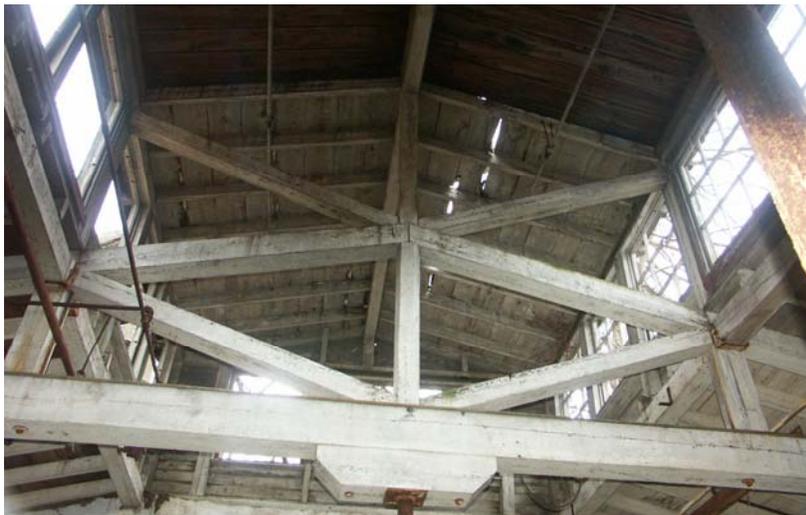
The interior of Section F is one large clearspan room. It is lit by the monitor, which has windows on all sides. A complicated Queen’s post truss system made of wooden beams frames the monitor; above the Queen’s posts is a raised King’s post truss which gives the entire truss a hexagonal appearance. The hexagonal framing elements stand on a corner above iron posts (see photos below); the sides of the hexagons support the framing for the clerestory windows, and the upper two angles support the monitor’s roof. Tie beams run from side wall to side wall as part of the Queen’s post truss system; iron posts with pillows support the center of the tie beams. The interior walls are plastered, and the floor is concrete. Parts of the truss woodwork is in excellent shape, while other areas are failing.

Photo 19. Detail of the complicated monitor truss system. Some of this framing is in excellent shape; other areas have collapsed.

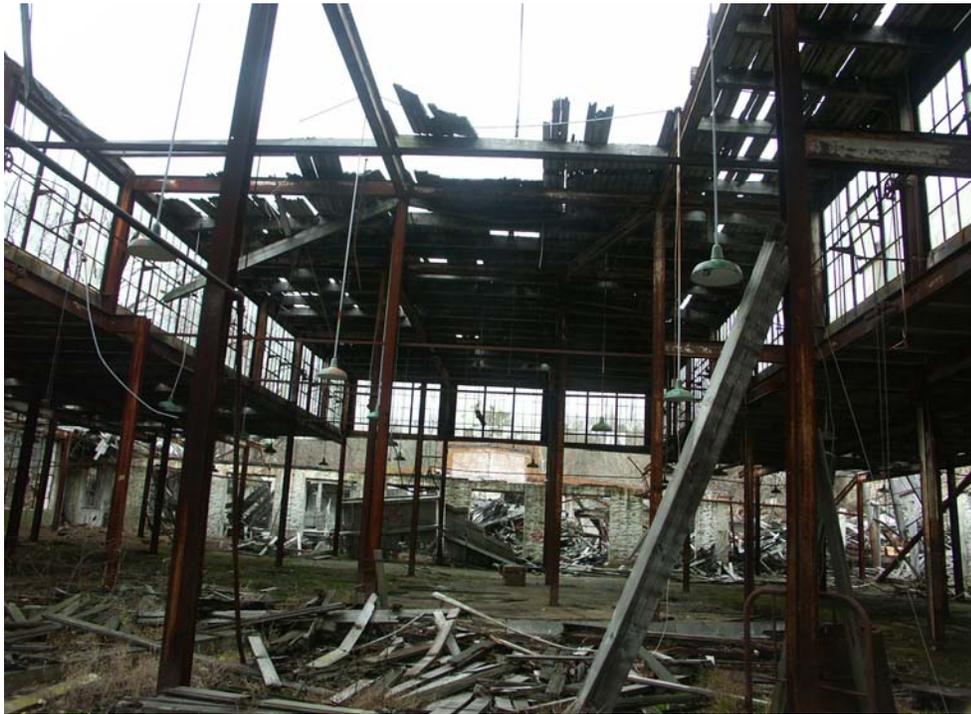
The interior is a single space with restrooms near the south corner. Portions of the framing for the monitor are intact, although the monitor itself is in poor condition. The steel interior framing system remains in place, consisting of the truss system and two rows of steel posts supporting the monitor. Counting the steel supports for the monitor, four rows of vertical steel I-beams divide the interior into five aisles. Steel rafters supporting the lower slope of the roof are attached to the steel uprights. Metal light fixtures hang by long chords from the steel rafters. The section has a concrete floor and plastered walls.

Photo 21. Interior of Section G, facing northwest, showing the large monitor roof system. Note the steel framing system and the lighting.

Section G condition: Poor. Roof failure has precipitated deterioration of the framing system. The interior steel structural system, however, does not appear to be in danger of imminent collapse.

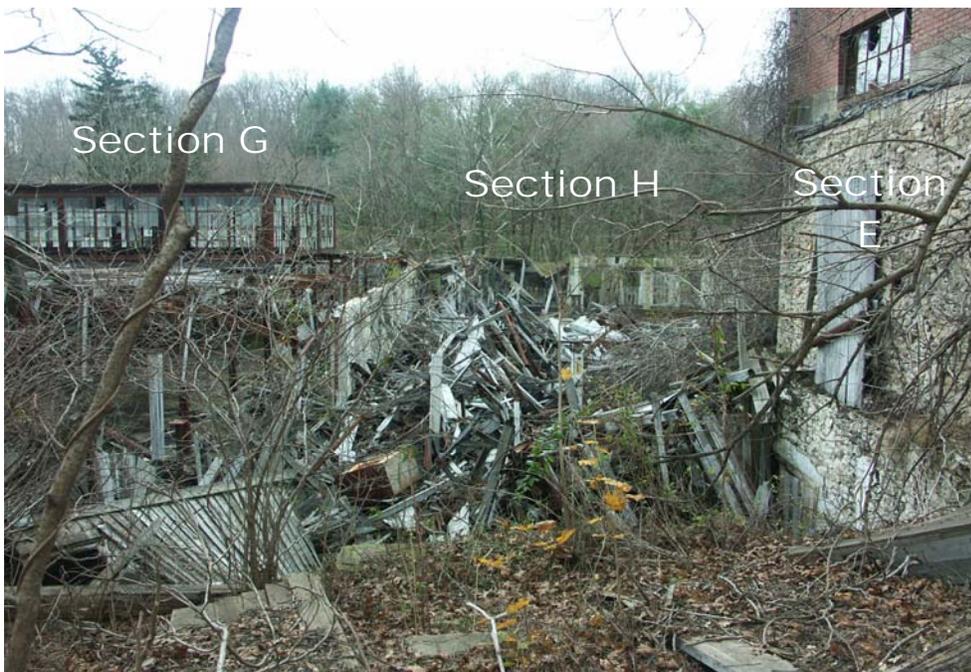
Photo 22. Ruins of Section H, facing southwest. Note the remnants of the monitor of Section G on the left and the wall of Section E on the right.

Section H is a two-story structure with an irregular footprint resulting from a bend in the creek. As originally constructed, the section had a nearly flat roof, which has entirely collapsed into the interior. The original exposed rafter tails are visible on the northwest and southwest elevations. The section has stone walls, stuccoed to the north. Much of the upper portion of the stone work has failed due to the collapse of the roof and subsequent pulling in of the masonry walls. Two stone, windowless rectangular elements along the creek are restroom additions; they were accessed from the interior with cleanouts along the creek. The northwest elevation was the location of the main entrance, where a large garage door leads into the interior. Windows on this narrow main elevation are mainly intact, with 8x8 windows on the second floor and larger 8x8 units on the first floor. The southwest wall has windows of various sizes and shapes, many of which are multi-light units in poor condition.

Section H condition: Ruinous. The section is quite dangerous due to the collapse of the roof and the resulting damage to the remaining interior framing. In addition, the stone wall along the creek shows signs of structural weakness; parts of the walls crumbled as the roof collapsed. The two stone-walled restrooms appear in fair condition.

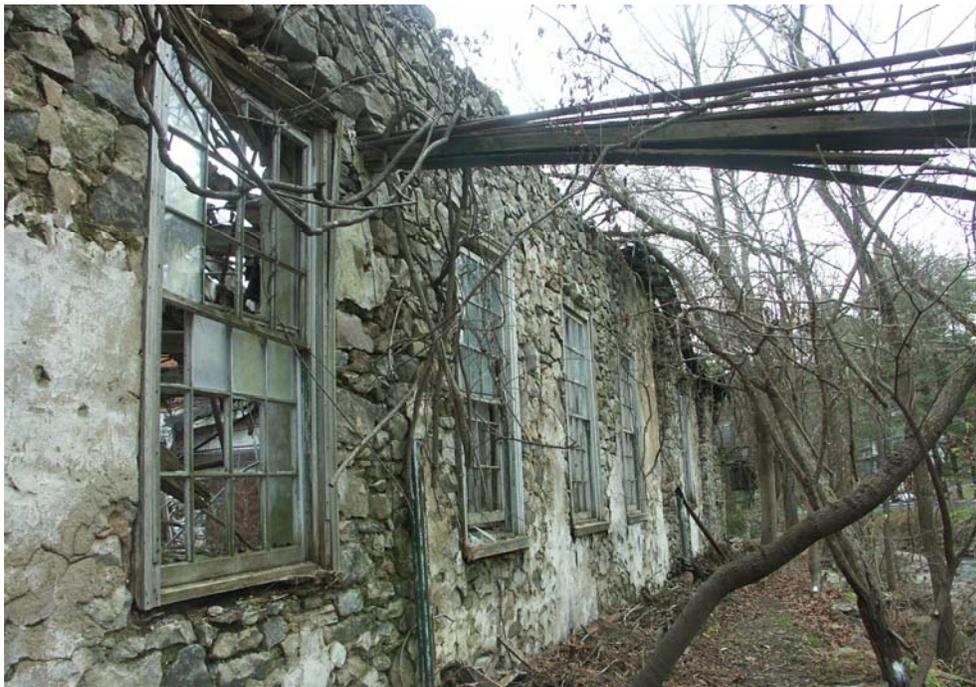
Photo 25. West wall of Section H, lining the east side of the creek.

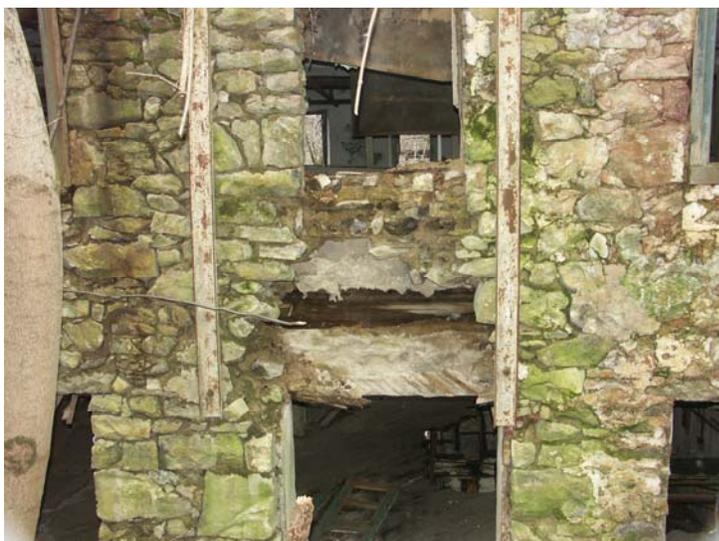
Photo 26. Damaged stone wall of Section C, northeast elevation. Much of the stone above the second floor window has fallen out.

Section C condition: Poor. Water penetration is becoming a major problem because the roof is beginning to fail and windows and doors are already missing. The brick cross-gabled addition is in fair to poor condition, having also lost its windows and doors.

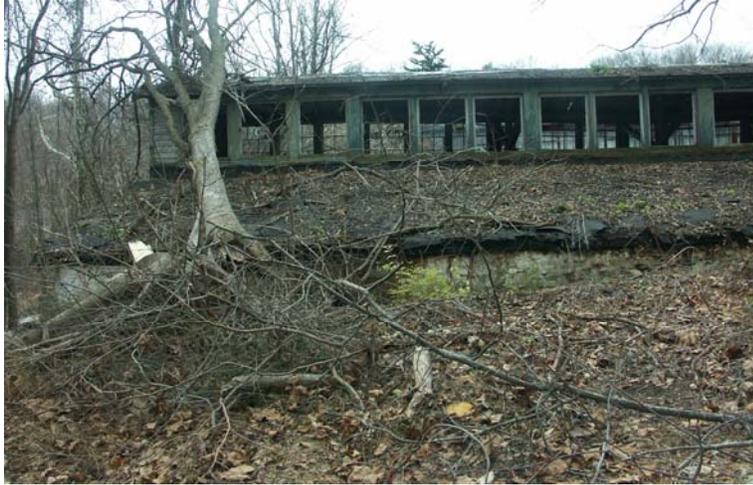
Photo 27. Detail of the monitor roof of Section F, as viewed from the hillside east of the section.

Section F condition: Poor. Water penetration is becoming more prevalent. Roof failure, however, has been minimal and much of the wooden truss system appears to be intact. Missing windows and doors represent the current sources of structural failure.

⁵ During the preparation of this report, it was brought to our attention that some citizens would like to conduct general repairs and stabilization to a portion of Section F. Insurance and other administrative considerations aside, this approach seems reasonable given the low costs.
