HISTORIC RESOURCE REPORT

PRELIMINARY FINDINGS

BONDSVILLE MILL

December 20, 2006

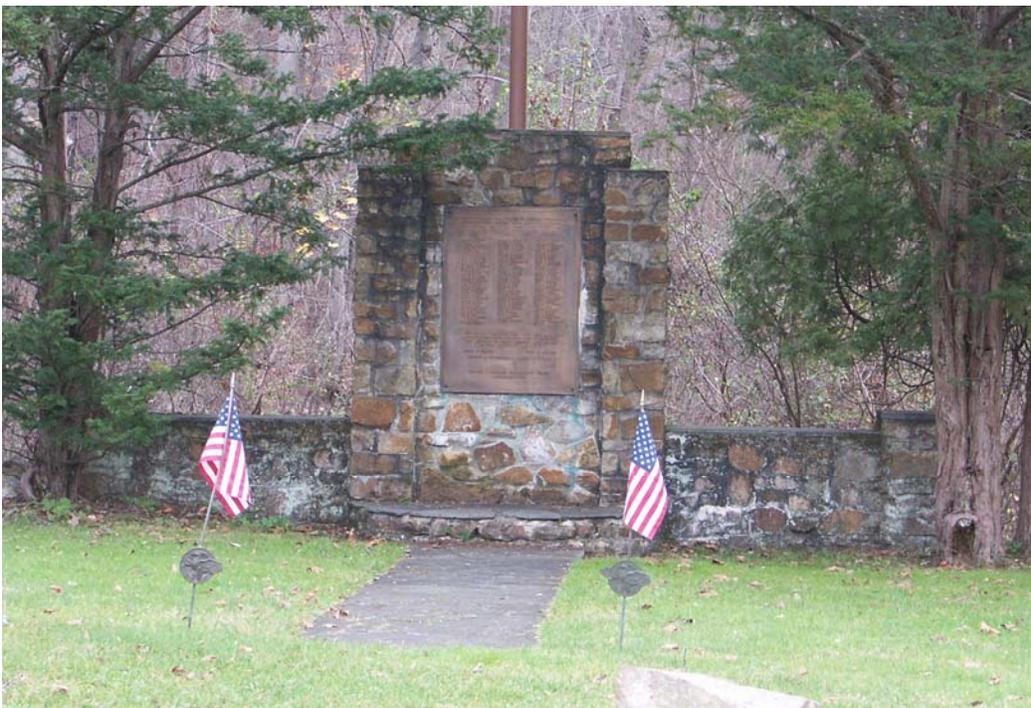
Photo 2. Veterans' Memorial, facing northeast.

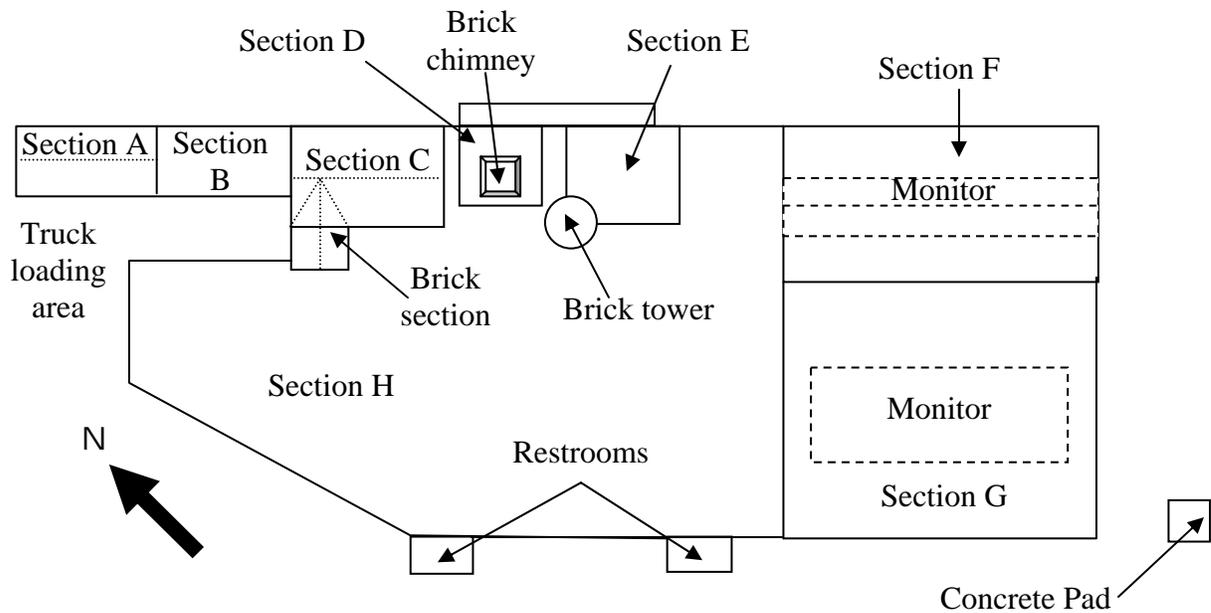
Figure 7. Mill complex.

The Mill was constructed in at least eight building campaigns, as shown in the site plan below. For ease of description, the sections are given letters beginning at the north end and proceeding clockwise.

An overview of the condition of individual sections is provided later in this report. The physical description includes information on the condition of some architectural elements. Terms used to describe condition are defined in the condition assessment. Some elements are described as “failing,” a term which denotes the feature which is in the process of deteriorating or becoming architecturally unstable.

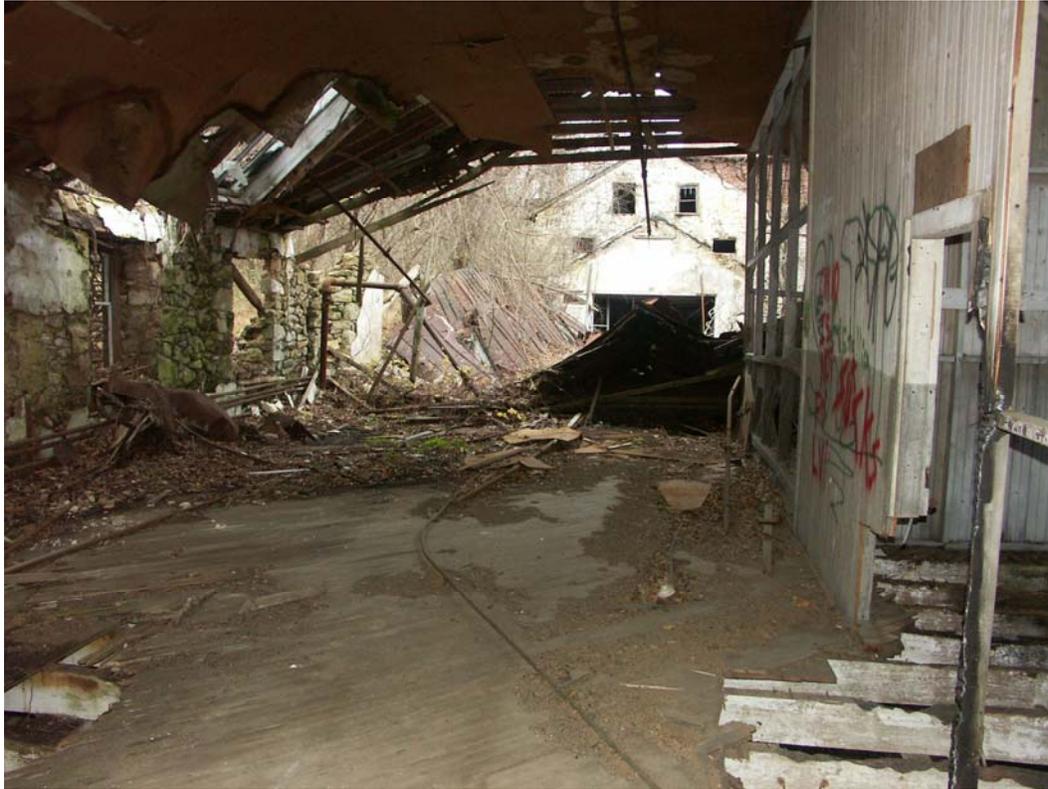
Photo 9. Interior of Section A, upper level, facing southeast. The open area in the center is Section B, looking through to Section C.

The interior of Section A consists of large storage areas on each floor. The second floor is accessed from the door on the northwest end of the section. Its interior has a plastered ceiling and walls and a hardwood floor with narrow boards nailed diagonally on the floor joists. A frame partition wall created office space overlooking the approach across the main bridge.

Section A condition: Poor. The roof is failing, which is allowing the interior framing system to deteriorate. Water infiltration is a growing problem. Wall openings are in poor condition, and the stucco is progressively failing. Much of the interior plasterwork has failed, partially in conjunction with the failure of the roof of Section B. Water infiltration precipitated a failure of the framing system in the northwest corner also, where a large hole is evident in the floor.

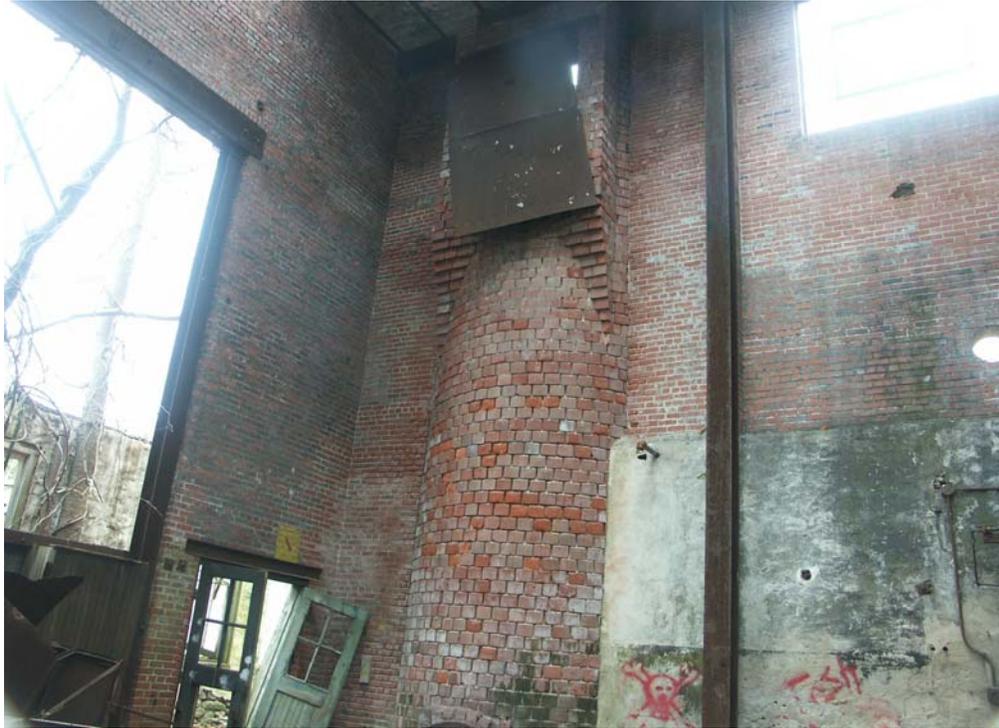
The main room of Section E is the historic boiler room. This space measures 30 feet by 35 feet, and the ceiling is 35 feet high. The boiler is located in the northeast corner. This metal and brick object was made by Coatesville Boiler Works, according to wording located above the two doors (see photo on next page). The boiler was vented by a large round brick chimney near the northwest corner of the section (see photo). A cleanout is located near the base of the round chimney.

Photo 14. Interior of boiler room, Section E, facing north. Note the large round chimney in center.

Sections D and E condition: Poor to Ruinous. Both sections exhibit structural failure, although the walls have not collapsed and the roof is somewhat intact. Due to the roof height and other concerns, this area is highly dangerous to enter.

- Section E, the power plant area. This high ceiling section is perhaps the most interesting part of the complex. It opens to the plant boiler (Section D) and the large round brick chimney. The section may be difficult to rehabilitate and maintain due to its size, height, and current condition.

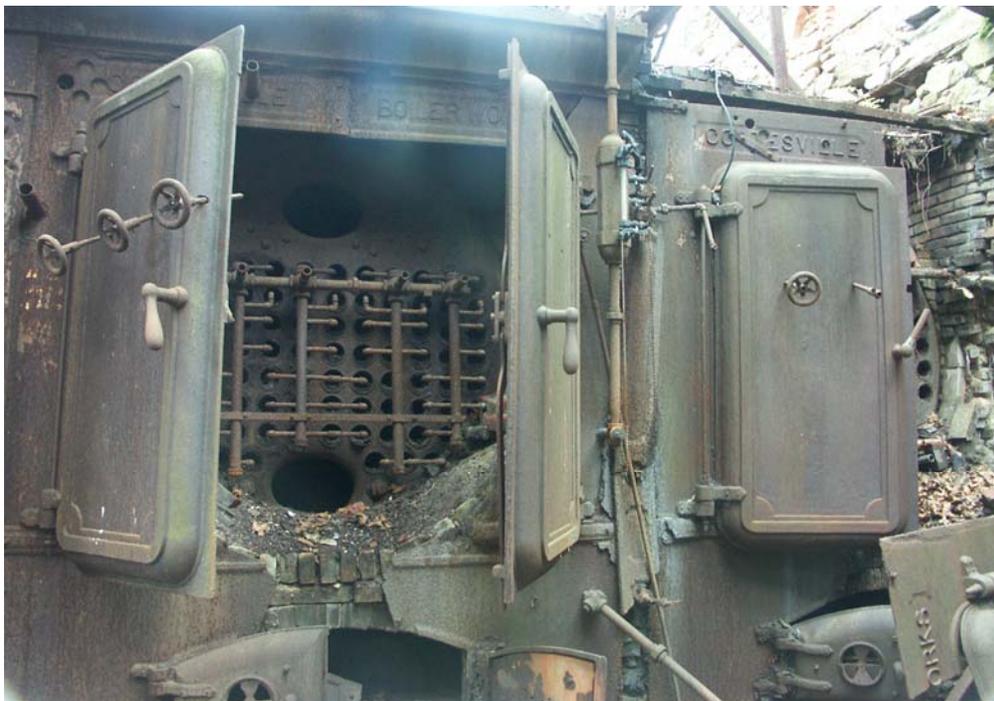
Photo 15. Boiler, located in the northeast corner of boiler room, Section E. Note the word "Coatesville" on the upper right.

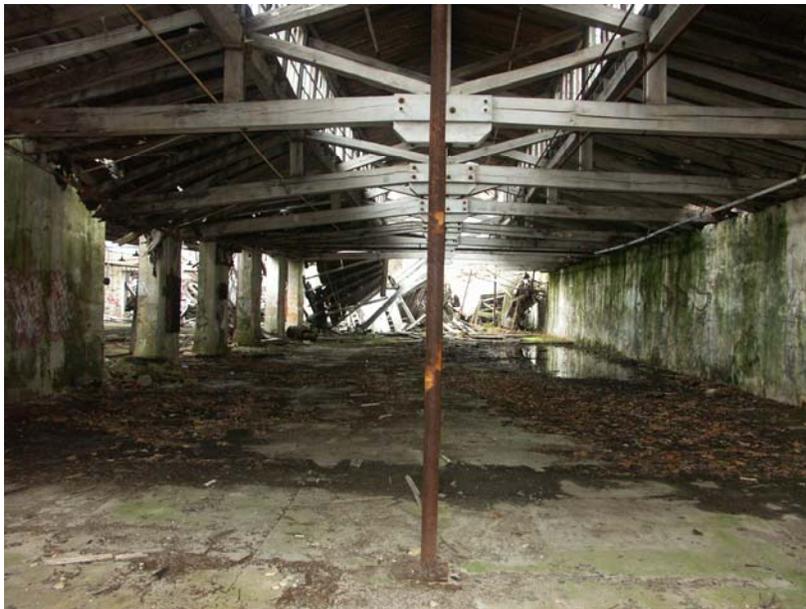
The interior of Section F is one large clearspan room. It is lit by the monitor, which has windows on all sides. A complicated Queen’s post truss system made of wooden beams frames the monitor; above the Queen’s posts is a raised King’s post truss which gives the entire truss a hexagonal appearance. The hexagonal framing elements stand on a corner above iron posts (see photos below); the sides of the hexagons support the framing for the clerestory windows, and the upper two angles support the monitor’s roof. Tie beams run from side wall to side wall as part of the Queen’s post truss system; iron posts with pillows support the center of the tie beams. The interior walls are plastered, and the floor is concrete. Parts of the truss woodwork is in excellent shape, while other areas are failing.

Photo 18. Interior of Section F, facing northwest. Note the column-free space and monitor roof above.

Section F condition: Poor. Water penetration is becoming more prevalent. Roof failure, however, has been minimal and much of the wooden truss system appears to be intact. Missing windows and doors represent the current sources of structural failure.

⁵ During the preparation of this report, it was brought to our attention that some citizens would like to conduct general repairs and stabilization to a portion of Section F. Insurance and other administrative considerations aside, this approach seems reasonable given the low costs.

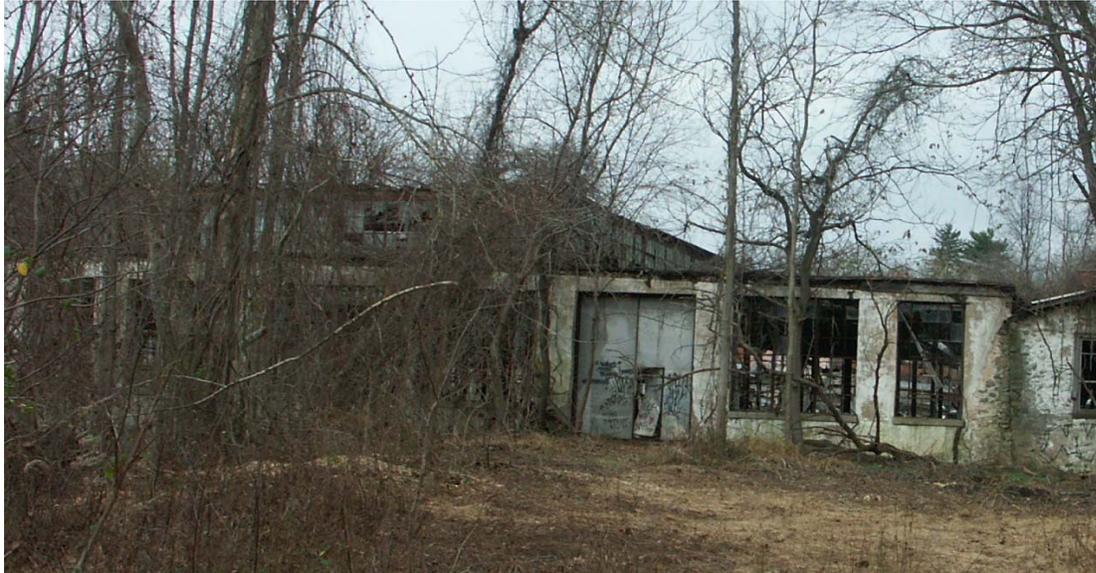
Photo 20. Section G, facing northwest.

Section G measures approximately 100’x120’, making it the second largest section (smaller than Section H). It is a one-story building, though its large monitor makes it in effect a two-story building. The monitor, which is much wider than that on Section F, is a raised area in the center which lights the interior by clerestory windows. The overall height is 18 feet. The roof is failing, particularly along the northwest end, where all that remains of the roof is the framing of the monitor. The section has stone walls with large multi-light windows running parallel to the creek on the southwest side. The southeast wall has a series of large window openings. The former main door was originally an overhead garage-type door, now partially sealed with sheet metal. It provides the only exterior entrance into the section.

The interior is a single space with restrooms near the south corner. Portions of the framing for the monitor are intact, although the monitor itself is in poor condition. The steel interior framing system remains in place, consisting of the truss system and two rows of steel posts supporting the monitor. Counting the steel supports for the monitor, four rows of vertical steel I-beams divide the interior into five aisles. Steel rafters supporting the lower slope of the roof are attached to the steel uprights. Metal light fixtures hang by long chords from the steel rafters. The section has a concrete floor and plastered walls.

Section G condition: Poor. Roof failure has precipitated deterioration of the framing system. The interior steel structural system, however, does not appear to be in danger of imminent collapse.

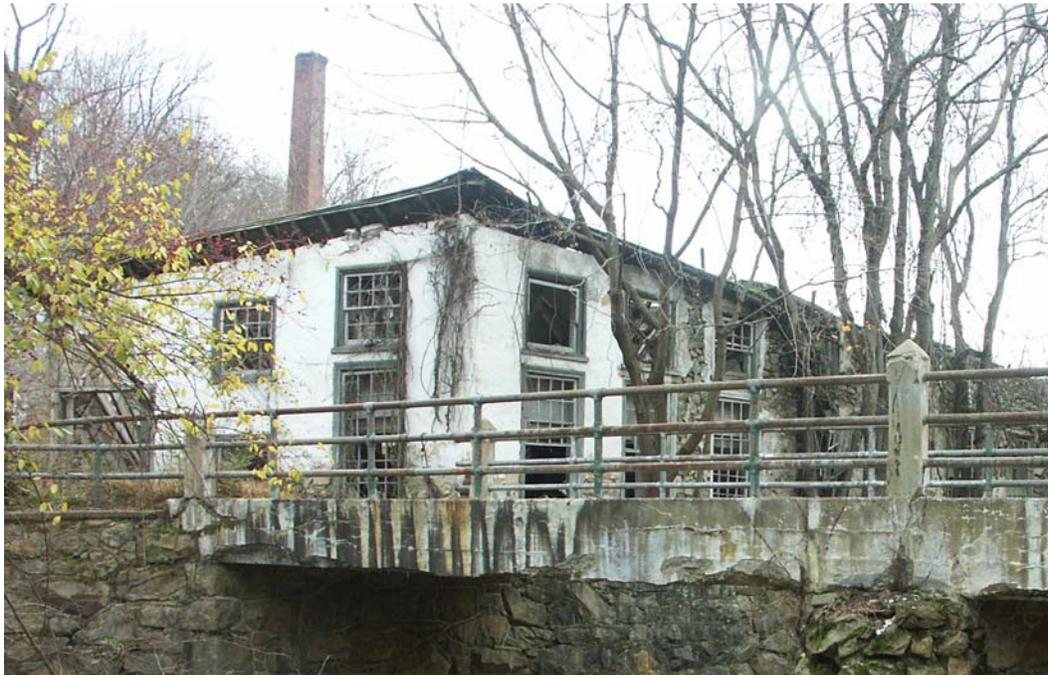
Photo 23. Section H, the main section of the mill complex, facing east from a point across the creek.

Section H is a two-story structure with an irregular footprint resulting from a bend in the creek. As originally constructed, the section had a nearly flat roof, which has entirely collapsed into the interior. The original exposed rafter tails are visible on the northwest and southwest elevations. The section has stone walls, stuccoed to the north. Much of the upper portion of the stone work has failed due to the collapse of the roof and subsequent pulling in of the masonry walls. Two stone, windowless rectangular elements along the creek are restroom additions; they were accessed from the interior with cleanouts along the creek. The northwest elevation was the location of the main entrance, where a large garage door leads into the interior. Windows on this narrow main elevation are mainly intact, with 8x8 windows on the second floor and larger 8x8 units on the first floor. The southwest wall has windows of various sizes and shapes, many of which are multi-light units in poor condition.

Section H condition: Ruinous. The section is quite dangerous due to the collapse of the roof and the resulting damage to the remaining interior framing. In addition, the stone wall along the creek shows signs of structural weakness; parts of the walls crumbled as the roof collapsed. The two stone-walled restrooms appear in fair condition.

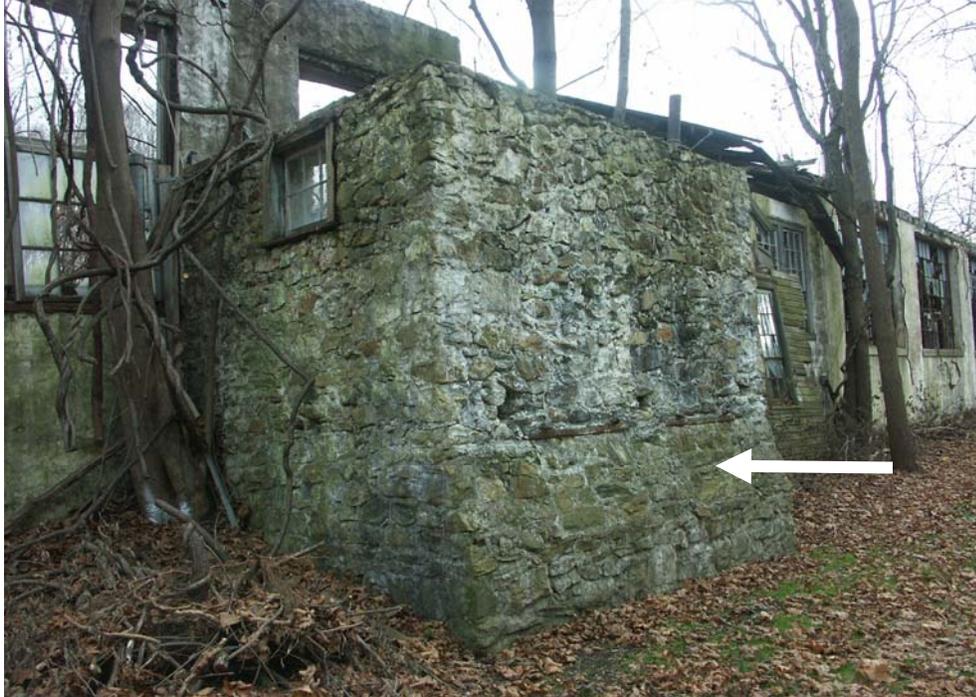
Photo 24. Privy attached to the exterior of Section H. The arrow points to one of the cleanouts.

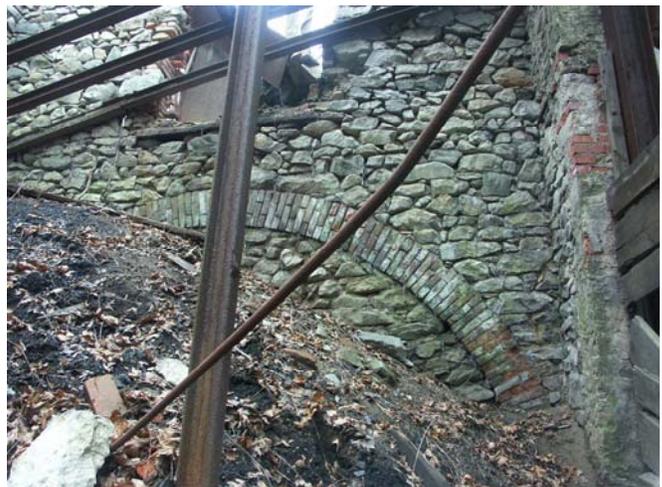
Photo 28. Detail of large brick arch over original tailrace on south wall of Section E.
